## **RESOLUTION AGREEMENT**

Westminster College  
OCR Docket Number 07102031

The Westminster College (College), Fulton, Missouri, submits this Resolution Agreement (Agreement) to the U.S. Department of Education, Office for Civil Rights (OCR), to resolve the allegations of discrimination based on disability against the College in the above-referenced complaint, and to ensure compliance with Section 504 of the Rehabilitation Act of 1973 (Section 504), 29 United States Code (U.S.C.) § 794, and its implementing regulations.

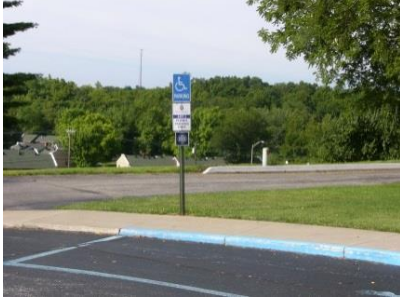
<p>The designated accessible parking space in front of Westminster Hall.</p>	<p>Ensure the designated accessible parking spaces in front of and behind Westminster Hall comply with 4.6, including compliance with the access aisle for a van, slope, and ensure the signs are at least 60” above the ground measured to the bottom of the sign. See Fig. 9, below. The College may move the designated accessible parking space on the horseshoe drive in front of Westminster Hall to the visitor parking area off the horseshoe drive by the flag near the other accessible parking space (across from the Westminster Historic Gym), since it may be difficult to ensure an accessible aisle on the one-way horseshoe drive.</p> <p>Allow students and other individuals</p>

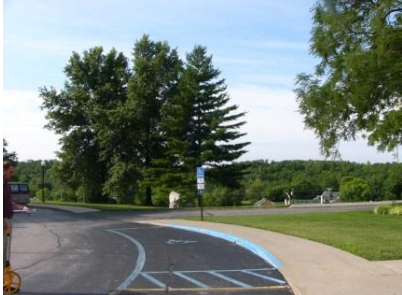
Location Surveyed: Westminster Hall	Uniform Federal Accessibility Standards (UFAS) <sup>2</sup> (unless noted otherwise)	Existing Measurements or Summary of Non-compliance	Photographs, if Available (enlarge electronically)	Remedial Action <sup>3</sup> UFAS Standards (unless noted otherwise)
	<p>4.6.3: Accessible space: 96" min. width.</p> <p>4.6.3: Accessible aisle: 60" min. width (96" min. width for van-accessible space)</p> <p>4.6.3: Accessible route: The access aisle shall be part of an accessible route to the facility entrance and shall comply with 4.3 (accessible route).</p> <p>4.6.3: Level Surface: The parking space and access aisles shall be level with surface slopes not exceeding 1:50 (2%) in all directions.</p> <p>4.6.4: Sign: Accessible spaces shall be reserved with a sign showing the symbol of accessibility (4.30.5) and signs shall not be obscured by a vehicle parked in the space.</p>	<p>vehicle parked in the space.</p> <p>The aisle for the designated accessible parking space in the back of Westminster Hall in Lot J is 58" wide, but should be a minimum of 60" wide.</p> <p>The sign for the designated accessible parking space in the back of Westminster Hall in Lot J is too low and can be obscured by a vehicle parked in the space. The accessible parking space in Lot J is restricted to permit-holders only.</p>

<p>The designated accessible parking space in front of Westminster Hall.</p>

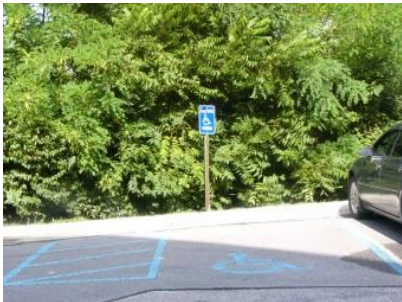
<p>The designated accessible parking space in the back of Westminster Hall (lot J).</p>	<p>with mobility impairments/permits to access these accessible parking spaces in addition to faculty and staff (Lot J is designated for faculty and staff only), given the distance and slope from the horseshoe drive to Lot J in the back of Westminster Hall.</p>

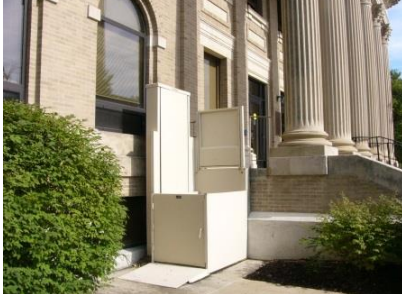
<p>Lift in front of Westminster Hall.</p>	<p>Ensure lift ramp is slip-resistant in compliance with 4.5.1.</p> <p>Ensure the sidewalk between the curb and the sidewalk to the lift has a slope that complies with 4.3.7 and 4.7.2.</p> <p>Ensure the lift can be used and operated independently by an individual with a disability. 4.11.3 and 34 C.F.R. §§ 104.4 and 104.21.</p>

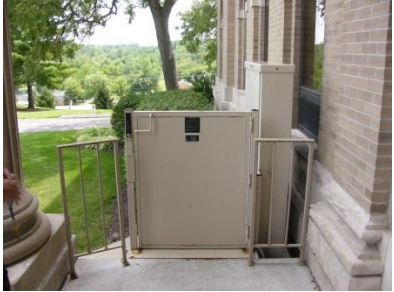
<p>View of lift near the entrance.</p>	
<p><b>Accessible route to the back entrance of Westminster Hall</b></p>	<p>Existing facility standards (34 C.F.R. §§ 104.21 and 104.22)</p> <p>Anti-discrimination standards (34 C.F.R. § 104.4)</p> <p>Guidance: Accessible Route: 4.3</p> <p>4.3.2(1): At least one accessible route within the boundary of the site shall be provided from public transportation stops, accessible parking, and accessible passenger zones, and public streets or sidewalks to the accessible building entrance they serve.</p> <p>4.3.2(2): At least one accessible route shall connect accessible buildings, facilities, elements, and spaces that are on the same site.</p> <p>See also 4.3.3-4.3.10.</p>	<p>The designated accessible route between the front and back entrance should comply with 4.3, including 4.3.3 (width), 4.3.4 (passing space), 4.3.5 (head room), 4.3.6 (surface textures), 4.3.7 (slope), 4.3.8 (changes in levels) and 4.3.9 (doors) requirements.</p>

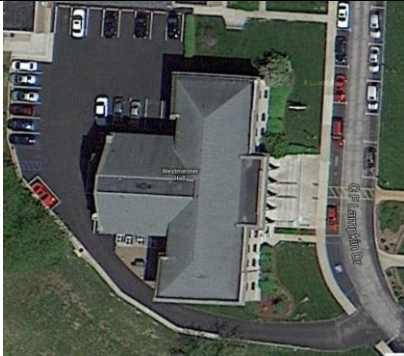
<p>Aerial view of Westminster Hall grounds, including sidewalks, drive behind Westminster Hall, and part of horseshoe drive.</p>	<p>Ensure there is an accessible route that complies with 4.3, including width, slope, and changes in level requirements, that connects the front and back accessible Westminster Hall entrances. 4.3.</p>

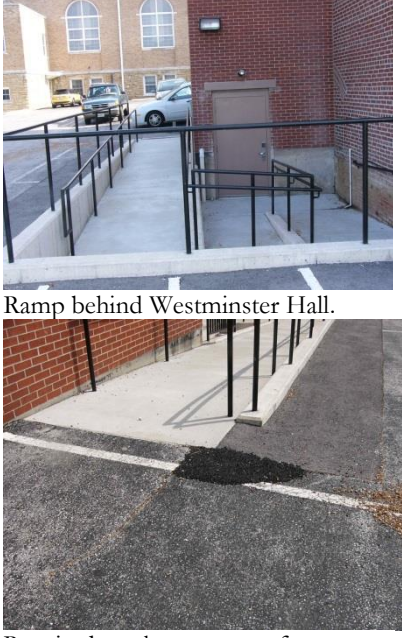
Location Surveyed: Westminster Hall	Uniform Federal Accessibility Standards (UFAS) <sup>2</sup> (unless noted otherwise)	Existing Measurements or Summary of Non-compliance	Photographs, if Available (enlarge electronically)	Remedial Action <sup>3</sup> UFAS Standards (unless noted otherwise)
<p><b>Ramp for back entrance of Westminster Hall</b></p>	<p><u>Ramps: 4.8:</u></p> <p>4.8.2: Max. slope: 1:12 (or 8.33%)</p> <p>4.8.3: Min. ramp width: 36"</p> <p>4.8.5: If a ramp run has a rise greater than 6" or a run greater than 72", then it shall have handrails on both sides.</p> <p>4.8.5(5): The top of handrail must be between 30" and 34" above ramp surface. At end of handrails, must be at least 12" of level handrail beyond the top &amp; bottom of the ramp segment.</p>	<p>The top of the handrail is 36" above the ramp surface, instead of between 30" and 34" above the surface. The bottom of the handrail also is too high: 35". See 4.8.5(5).</p>

<p>Ramp behind Westminster Hall.</p> <p>Repaired cracks near top of ramp.</p>	<p>Ensure the top and bottom of the handrail is between 30" and 34" above the ramp surface.</p> <p>Maintain asphalt and cement of accessible route, including maneuvering areas, ramps, and landings, to promptly address any cracks and holes in the future.</p>

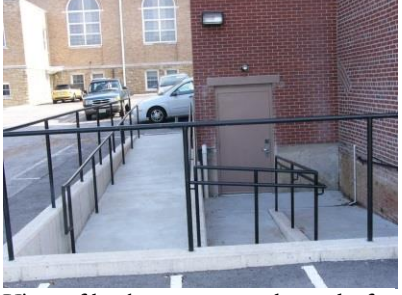
<p>View of back entrance at the end of the ramp.</p>	<p>Install a sign that complies with 4.30, using the international symbol of accessibility. See Fig. 43, below. Also install directional signage to accessible entrance for lower level.</p>

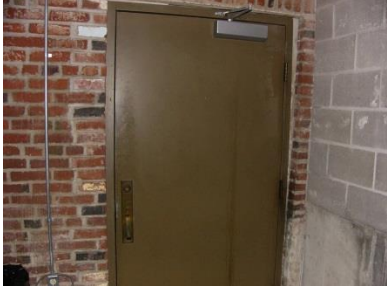
Location Surveyed: Westminster Hall	Uniform Federal Accessibility Standards (UFAS) <sup>2</sup> (unless noted otherwise)	Existing Measurements or Summary of Non-compliance	Photographs, if Available (enlarge electronically)	Remedial Action <sup>3</sup> UFAS Standards (unless noted otherwise)
<p><b>Back entrance to Westminster Hall at the end of ramp</b></p>	<p><u>Doors: 4.13:</u></p> <p>4.13.9: Handles, pulls, latches, locks, and other operating devices on accessible doors shall have a shape that is easy to grasp with one hand and does not require tight grasping, tight pinching, or twisting of the wrist to operate. Lever-operated mechanisms, push-type mechanisms, and U-shaped handles are acceptable designs. Hardware must be mounted no higher than 48” above the floor.</p> <p>4.13.11: The maximum force for pushing or pulling open an interior hinged door is 5 lbs. No opening force is specified for exterior doors.</p>	<p>The door handle (inside) requires a high degree of dexterity and coordination and is not easy to grasp or use.</p> <p>The opening force of the exterior door was between 7 and 10 lbs. While there are no specific UFAS standards for maximum door opening force for exterior hinged doors, the opening force of 7 to 10 lbs. for the exterior door greatly exceeds the 5 lb. maximum force considered suitable for people with disabilities with respect to interior hinged doors. See 4.13.11.</p> <p>The opening force of the interior door leading to the lower level corridor was at least 7 lbs.</p>

<p>Door for back entrance of Westminster Hall.</p>	<p>Install an automatic door opener for the outside door at the bottom of the ramp in accordance with 4.13.12. While there is no specific opening force standard in UFAS for an exterior hinged door, the existing opening force could exclude individuals with disabilities from accessing the lower level of the building, contrary to 34 C.F.R. § 104.4 (Section 504 general anti-discrimination provisions) and 34 C.F.R. § 104.21 (Section 504 anti-discrimination provision regarding accessibility).</p> <p>Ensure the interior door leading to the lower level corridor has a maximum opening force of 5 lbs.</p>

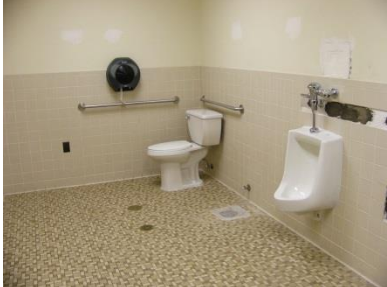
<p><b>Lower Level of Westminster Hall</b></p> <p><b>Unisex Restroom</b></p>	<p><u>Toilet Rooms: 4.1.2(10) and 4.22,</u> including 4.16 (water closets or toilets), 4.17 (toilet stalls), 4.18 (urinals), 4.19 (lavatories or sinks and mirrors), 4.26 (grab bars), and 4.27 (controls and operating mechanisms).</p> <p>4.30: Signage: See 4.30.2-5 requirements pertaining to character proportion, color contrast, raised characters or symbols, and symbols of accessibility.</p> <p>4.30.6: Interior signage shall be located alongside the door on the latch side and shall be mounted at a height of between 54” and 66” above the finished floor.</p>	<p>The College remodeled the unisex bathroom in the lower level of Westminster Hall after OCR’s initial onsite accessibility survey. The bathroom was still being altered when OCR returned to the College (see photo in next column).</p> <p>Please note: In toilet rooms with only one water closet and one lavatory, a clear floor space of 30” x 60” may be used in lieu of the unobstructed turning space. See exception to 4.22.3.</p>

<p>Alterations were in progress in unisex bathroom during OCR’s return onsite survey at the College.</p>	<p>Ensure the remodeled unisex bathroom in the lower level complies with the UFAS standards for 4.22 &amp; 4.23, including 4.16, 4.17, 4.19, 4.26, and 4.27.</p> <p>Install a sign on the latch side of the unisex bathroom door that complies with 4.30, using the international symbol of accessibility. See Fig. 43, below:</p>

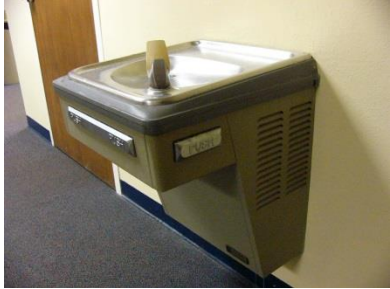
Location Surveyed: Westminster Hall	Uniform Federal Accessibility Standards (UFAS) <sup>2</sup> (unless noted otherwise)	Existing Measurements or Summary of Non-compliance	Photographs, if Available (enlarge electronically )	Remedial Action <sup>3</sup> UFAS Standards (unless noted otherwise)
<p><b>Lower Level of Westminster Hall</b></p> <p><b>Drinking Fountain</b></p>	<p><u>Drinking Fountains: 4.15:</u></p> <p>4.15.5(1): Clearances: Wall and post mounted cantilevered units shall have a clear knee space between the bottom of the apron and the floor or ground at least 27" high, 30" wide, and 17" to 19" deep. Such units shall also have a minimum clear floor space 30" by 48" to allow an approach facing forward. See Fig. 27(a) and (b).</p>	<p>The height between the bottom of the apron and the ground is 25" high; it should be at least 27" high.</p>

<p>Drinking fountain in lower level.</p>	<p>Ensure the wall-mounted drinking fountain complies with the requirements of 4.15, including complying height and clearances. See Fig. 27(a), below, for a wall-mounted cantilevered unit:</p>

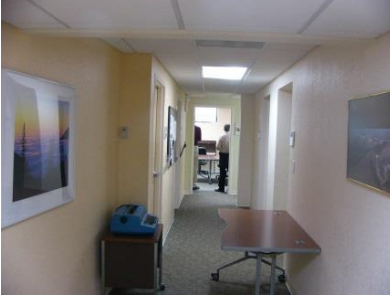
<p>Corridor in Learning Opportunity Center</p>	<p>Ensure that objects such as tables and carts are not placed in the accessible route if those objects reduce the width of the accessible route less than 36".</p>

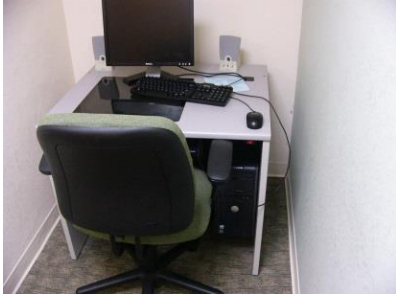
<p>Test Room #40.</p>

Location Surveyed: Westminster Hall	Uniform Federal Accessibility Standards (UFAS) <sup>2</sup> (unless noted otherwise)	Existing Measurements or Summary of Non-compliance	Photographs, if Available (enlarge electronically)	Remedial Action <sup>3</sup> UFAS Standards (unless noted otherwise)
<p><b>Lower Level of Westminster Hall</b></p> <p><b>Seating, Tables, and Work Surfaces</b></p>	<p><u>Seating, Tables, &amp; Work Surfaces:</u> <u>4.1.2(17) &amp; 4.32:</u></p> <p>4.1.2(17): If fixed or built-in seating, tables, or work surfaces are provided in accessible spaces, at least 5%, but always at least one, of seating spaces, tables, or work surfaces shall comply with 4.32.</p> <p>4.32.2: Seating: If seating spaces for people in wheelchairs are provided at tables, counters, or work surfaces, clear floor space complying with 4.2.4 shall be provided. Such clear floor space shall not overlap knee space by more than 19".</p> <p>4.32.3: Knee Clearances: If seating for people in wheelchairs is provided at tables, counter, and work surfaces, knee spaces at least 27" high, 30" wide, and 19" deep shall be provided.</p> <p>4.32.4: Height of Work Surfaces: The tops of tables and work surfaces shall be from 28" to 34" from the floor.</p> <p>34 C.F.R. § 104.4 (Section 504 general anti-discrimination provisions)</p>	<p>The dimensions for the table in Test Room #40 are as follows:</p> <p>Height: 25" from the bottom of the keyboard shelf to the floor. 30" from the top of the table to the floor, but the keyboard is below the table.</p> <p>Width: 25" wide underneath the table. Table top width is 36", but the width is reduced under the table because of the tower.</p> <p>Depth: 28" from the front of the table to the back, but depth is affected by objects under the table.</p> <p>Knee clearance should be at least 27" high, 30" wide, and 19" deep at accessible tables and work areas.</p> <p>The tables in the private test and study rooms do not comply with the knee clearance dimensions for an individual in a wheelchair. See 4.32.3. While these tables do not appear to be fixed or built-in, an individual using a wheelchair should not be excluded from the opportunity to take a test or study in a private room, pursuant to 34 C.F.R. §§ 104.4 and 104.21 (Section 504 anti-discrimination provisions).</p>

<p>Study Room #37 (view under table)</p>	<p>It appears these tables can meet the knee clearance requirements with some modifications, such as moving the computer tower and reconfiguring the keyboard and objects underneath the table.</p> <p>Ensure one private test room and one private study room is accessible with accessible tables, and ensure the rooms have sufficient clear floor space to maneuver with the door closed (or provide OCR with a plan to ensure students with disabilities are provided a private enclosed test and study area). Also provide audible and visual alarms that comply with 4.28 in each accessible private test and study room.</p> <p>Ensure a 36" accessible route to accessible elements, including tables, computer tables, and bookcases, is maintained within the study lab. See Fig. 45 (a portion is reprinted, below):</p>

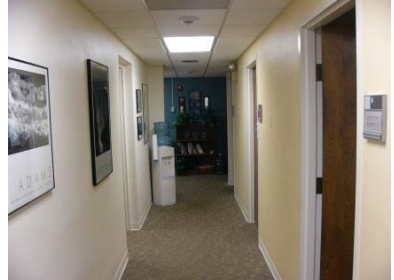
<p data-bbox="65 922 281 1010"><b>Lower Level of Westminster Hall</b></p> <p data-bbox="65 1042 281 1130"><b>Corridor in Counseling &amp; Health Services</b></p>	<p data-bbox="281 922 709 961"><u>Accessible Route: 4.3:</u></p> <p data-bbox="281 977 709 1075">4.3.3: Width: The minimum clear width of an accessible route shall be 36” except at doors.</p>	<p data-bbox="709 922 1171 1010">A water cooler obstructs the accessible route in the corridor of the Counseling &amp; Health Services area.</p>

<p data-bbox="1186 1205 1577 1268">Corridor in the Counseling &amp; Health Services area</p>	<p data-bbox="1591 922 2032 1042">Ensure that objects such as the water cooler are not placed in the accessible route if those objects reduce the width of the accessible route less than 36”.</p>

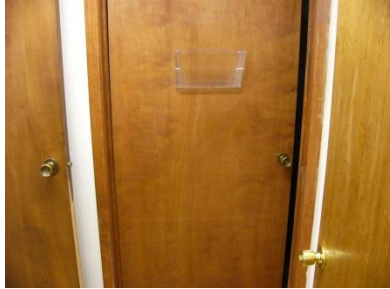
Location Surveyed: Westminster Hall	Uniform Federal Accessibility Standards (UFAS) <sup>2</sup> (unless noted otherwise)	Existing Measurements or Summary of Non-compliance	Photographs, if Available (enlarge electronically)	Remedial Action <sup>3</sup> UFAS Standards (unless noted otherwise)
<p><b>Lower Level of Westminster Hall</b></p> <p><b>2<sup>nd</sup> Exam Room</b></p>	<p><u>Doors: 4.1.2(7)(b) &amp; 4.13:</u></p> <p>4.1.2(7)(b): Within a building or facility, at least one door at each accessible space shall comply with 4.13.</p> <p>4.13.5: Clear Width: Doorways shall have a minimum clear opening of 32” with the door open 90 degrees, measured between the face of the door and the stop.</p>	<p>The door to the 2<sup>nd</sup> Exam Room is 30” wide, which is less than the required 32” depth at doorways.</p>

<p>Door to 2<sup>nd</sup> Exam Room</p>

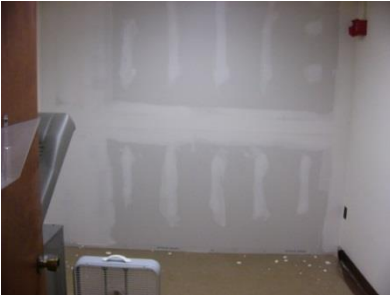
<p>2<sup>nd</sup> Exam Room under construction.</p>	<p>Increase the width of the door to the 2<sup>nd</sup> Exam Room if the College is using this space for students or others. At the time OCR surveyed this room, it was under construction (see below):</p>

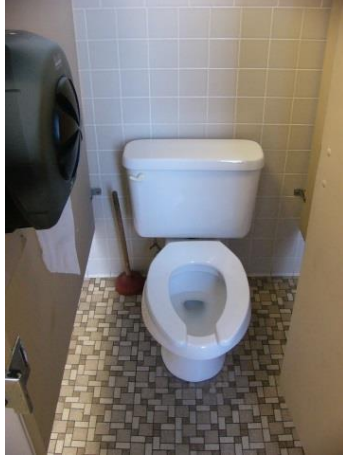
<p>One of the men’s toilet stalls in the men’s restroom.</p>	<p>Alter the men’s and women’s restrooms on the main level in compliance with 4.22 and 4.30, so that individuals in wheelchairs or with mobility impairments can access accessible restrooms on the main level without exiting the building via the platform lift and traveling in the outside elements around the building (or driving a car and parking), and through the ramp and lower level to access the unisex restroom. 34 C.F.R. §§ 104.4 and 104.21.</p>

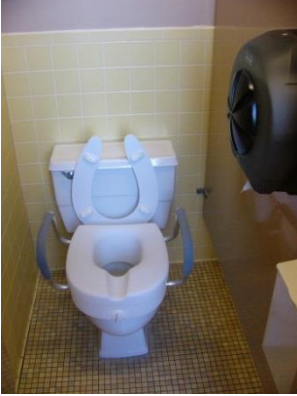
<p><b>Main level of Westminster Hall</b></p> <p><b>Men’s and women’s restroom</b></p>	<p>Existing building standards: 34 C.F.R. §§ 104.21 and 104.22</p> <p>Anti-discrimination standards: 34 C.F.R. § 104.4.</p> <p>Guidance: Toilet Rooms: 4.1.2(10) and 4.22, including 4.16 (water closets or toilets), 4.17 (toilet stalls), 4.18 (urinals), 4.19 (lavatories or sinks and mirrors), 4.26 (grab bars), and 4.27 (controls and operating mechanisms).</p> <p>Guidance: 4.30: Signage: See 4.30.2-5 requirements pertaining to character proportion, color contrast, raised characters or symbols, and symbols of accessibility. See also 4.30.6: Interior signage shall be located alongside the door on the latch side and shall be</p>	<p>The men’s and women’s restrooms on the main level (first floor) are public or common use restrooms that are not accessible to individuals in wheelchairs. For both restrooms the entrance doors exceed 5 lbs. and the toilet stall doors are less than 32” wide. The women’s entrance door is also less than 32” wide.</p> <p>In addition, both restrooms do not have adequate maneuvering spaces or clearance under sinks, there are no wall-mounted grab bars, and mirrors are not mounted high enough, and pipes under the sinks are not insulated.</p> <p>The signs on the restroom doors do not include international signs of accessibility or braille, and are not mounted on the latch side of the door (see photos, below).</p>

<p>One of the women’s toilet stalls in the women’s restroom.</p>	(see above)
<b>Main level of Westminster Hall</b>  <b>Service Counters</b>	<p>Existing building standards: 34 C.F.R. §§ 104.21 and 104.22</p> <p>Anti-discrimination standards: 34 C.F.R. § 104.4.</p> <p>Guidance: Service Counters: 7.2: Where service counters exceeding 36” in height are provided for standing sales or distribution of goods to the public, an auxiliary counter or portion of the main counter shall be provided with a maximum height of between 28” to 34” above the floor.</p> <p>Guidance: Protruding objects: 4.4.1 &amp; 4.4.2: Wall-mounted objects with leading edges between 27” and 80” above the floor shall protrude no more than 4” into walks, halls, corridors, passageways, or aisles, and there shall be a minimum of 80” of clear head room.</p>	<p>The service counters for student accounts (photo in next column), and in the business office (below), the registrar’s office, and the academic affairs office, exceed 36” in height with no auxiliary counter between 28” to 34” above the floor.</p> <p>One of the service counters in the business office.</p> <p>The signs above service counter appear to be less than 80” above the floor.</p>

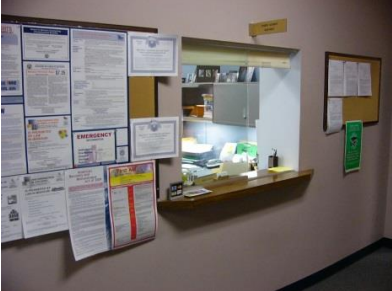
<p>Service counter for student accounts.</p>	<p>For service counters where business is conducted, provide an auxiliary counter mounted between 28” to 34” above the floor, so individuals in wheelchairs can independently conduct business, including writing checks, signing documents, etc. (or provide OCR with a plan to provide equivalent accessibility). 34 C.F.R. §§ 104.4 and 104.21.</p> <p>In addition, ensure that service counters exceeding 4” in depth have a fixed cane-detectible barrier below the counters, and remove any objects that are less than 80” above the floor, such as the rectangle signs mounted above the service counters for student accounts and in the business office (see photos in third and fourth columns and Fig. 8(a) in protrusion section, below).</p>

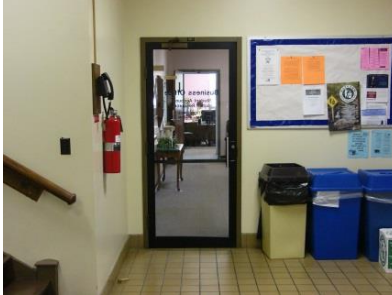
Location Surveyed: Westminster Hall	Uniform Federal Accessibility Standards (UFAS) <sup>2</sup> (unless noted otherwise)	Existing Measurements or Summary of Non-compliance	Photographs, if Available (enlarge electronically)	Remedial Action <sup>3</sup> UFAS Standards (unless noted otherwise)
<p><b>Westminster Hall: All levels</b></p> <p><b>Interior doors and signage</b></p>	<p>Existing building standards: 34 C.F.R. §§ 104.21 and 104.22</p> <p>Anti-discrimination standards: 34 C.F.R. § 104.4.</p> <p>Guidance: Doors: 4.13.11: The maximum force for pushing or pulling open an interior hinged door is 5 lbs.</p> <p>Guidance: Signage: 4.1.2(15) &amp; 4.30.6: Interior signage shall be located alongside the door on the latch side and shall be mounted at a height of between 54” and 66” above the floor.</p>	<p>On the main level of Westminster Hall, the opening force for the door to the business office is from 9 lbs. to 12 lbs.</p> <p>The door does not have a sign located on the latch side of the door.</p>

<p>Entrance to Business Office.</p>	<p>Ensure the opening force for the business office door and all other interior doors in Westminster Hall have a maximum opening force of 5 lbs, to allow individuals with disabilities independent access. 34 C.F.R. §§ 104.4 and 104.21.</p> <p>Provide signage on the latch side of the door between 54” and 66” above the floor, in conformance with 4.30, for all permanent offices, rooms, and spaces in Westminster Hall with signs. OCR recommends including braille in the signage, so individuals with vision impairments can independently access the offices, rooms, and spaces. 34 C.F.R. §§ 104.4 and 104.21.</p>

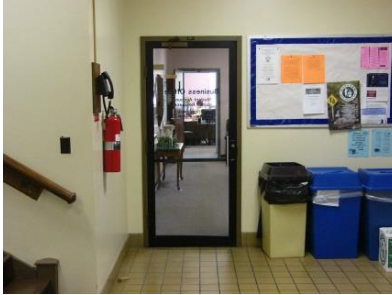
<p>Protrusions near entrance to business office.</p>	<p>Provide a fixed barrier detectable by canes under the protruding objects or provide OCR with another plan to reconfigure or eliminate each protrusion. In addition, remove any objects that are less than 80” above the floor (such as the rectangular signs above the service counters), unless there is a can-detection area (where appropriate). See Fig. 8(a), below. 34 C.F.R. §§ 104.4 and 104.21.</p>

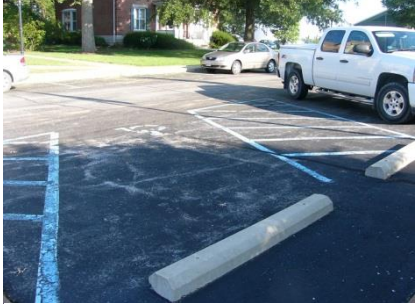
<p style="text-align: center;">Westminster Historic Gym</p>	
Gym Parking	<p>Existing facility standards (34 C.F.R. §§ 104.21 and 104.22)</p> <p>Anti-discrimination standards (34 C.F.R. § 104.4)</p> <p>Guidance: Parking: 4.1.1(5)(a) &amp; 4.6:</p> <p>4.1.1(5)(a): Scope: 1-25 total parking spaces in a parking area require 1 accessible parking space (see table for additional spaces).</p> <p>4.6.2: Accessible parking spaces shall be located closest to the nearest accessible entrance on an accessible route.</p> <p>4.6.3: Accessible space: 96" min. width.</p> <p>4.6.3: Accessible aisle: 60" min. width (96" min. width for van-accessible space).</p> <p>4.6.3: Accessible route: The access aisle shall be part of an accessible route to the facility entrance and shall comply with 4.3 (accessible route).</p>	<p>The Gym has a designated accessible parking space across from the Gym off the horseshoe drive with a curb cut on the west side of the drive. This parking area has 6 parking spaces, one of which is designated accessible.</p> <p>In addition, there is a designated accessible parking space in Lot K between the Washington West House and the Hunter Activity Center, which the College indicated could be used for the Gym. Lot K has 16 parking spaces, one of which is accessible for a car. However, the access aisle is only 56" wide, rather than a required width of 60" for a car (or 96" wide for a van).</p>

<p>Accessible parking space across from the Gym off the horseshoe drive. See blue arrow in aerial picture, below:</p>

<p>Lot K: Increase the access aisle to 60" width for a car (see Fig. 9, below) or 96" width for a van for the accessible parking space(OCR recommends at least one van-accessible parking space), and include a sign designating the space as van-accessible if designated as van-accessible.</p> <p>Allow students and other individuals with mobility impairments to access this accessible parking space in addition to faculty and staff (Lot K is designated for faculty and staff only), given the limited amount of parking available to several College buildings south of 7th street and west of Westminster Avenue.</p> <p>The College may consider converting the northeast parking space on the south side of the Gym near the front entrance in Lot J (see red arrow in aerial picture in the previous column) to an accessible parking space for the Gym, since the distance to the Gym would be significantly shorter than the distance from the designated accessible parking space in Lot K to the Gym entrance.</p>

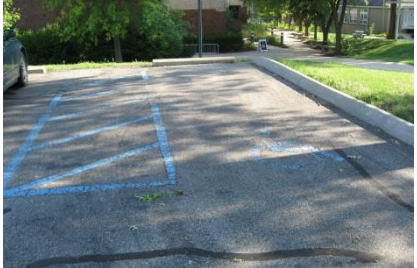
Location Surveyed: Westminster Historic Gym	Uniform Federal Accessibility Standards (UFAS) (unless noted otherwise)	Existing Measurements or Summary of Non-compliance	Photographs, if Available (enlarge electronically)	Remedial Action UFAS Standards (unless noted otherwise)
	<p>4.6.3: Level Surface: The parking space and access aisles shall be level with surface slopes not exceeding 1:50 (2%) in all directions.</p> <p>4.6.4: Sign: Accessible spaces shall be reserved with a sign showing the symbol of accessibility (4.30.5) and signs shall not be obscured by a vehicle parked in the space.</p>

<p>Designated accessible parking space in Lot K between the Washington West House and the Hunter Activity Center.</p>

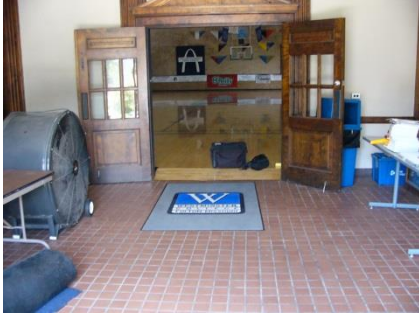
Location Surveyed: Westminster Historic Gym	Uniform Federal Accessibility Standards (UFAS) (unless noted otherwise)	Existing Measurements or Summary of Non-compliance	Photographs, if Available (enlarge electronically)	Remedial Action UFAS Standards (unless noted otherwise)
<p><b>Gym</b></p> <p><b>Court area in main level</b></p>	<p>Existing facility standards (34 C.F.R. §§ 104.21 and 104.22)</p> <p>Anti-discrimination standards (34 C.F.R. § 104.4)</p> <p>Guidance: Assembly Areas: 4.1.2(18) and 4.33:</p> <p>4.1.2(18): Assembly areas: See table with the seating capacity and number of required wheelchair locations: For a seating capacity of 501-1,000 seats, 2% of the total, or 13 accessible wheelchair locations.</p> <p>4.33.2: Size of Wheelchair Locations: Each wheelchair location shall provide minimum clear ground or floor spaces as shown in Fig. 46.</p> <p>4.33.3: Placement of Wheelchair Locations: Wheelchair areas shall be an integral part of any fixed seating area. They shall adjoin an accessible route that also serves as a means of egress in case of emergency and shall be located to provide lines of sight comparable to those for all viewing areas.</p> <p>4.33.4: Surfaces: The ground or floor at wheelchair locations shall be level and shall comply with 4.5.</p> <p>4.13: Doors</p>	<p>There are 506 bleacher seats on the north side of the court and 144 bleacher seats on the south side, for a total of 650 bleacher seats. There are 6 designated accessible wheelchair seating areas on in the north bleachers, with companion seating for each accessible wheelchair seating location.</p> <p>4.1.2(18) requires 13 accessible wheelchair seating locations based on 2% of the total seating capacity of 650. The Gym has only 6 accessible wheelchair seating locations.</p> <p>The doors to the court area may have compliance issues concerning the handles, thresholds and opening force.</p>

<p>Entrance to court area of Gym.</p>

<p>Bleachers on the south side of the court.</p>	<p>Ensure the accessible wheelchair seating locations comply with 4.33 when fully extended and the bleachers do not encroach on the accessible route (36" wide) when fully extended. See Fig. 46(a), below.</p> <p>Provide OCR with a plan to provide additional wheelchair seating locations (up to 7 additional wheelchair locations) if the need arises.</p> <p>If the doors to the court area are not kept open during business and event hours, ensure the doors comply with 4.13.</p>

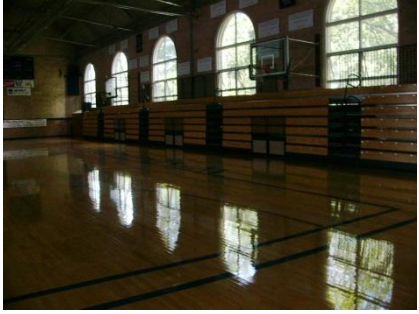
<p>Bleachers on the north side of the court:</p>

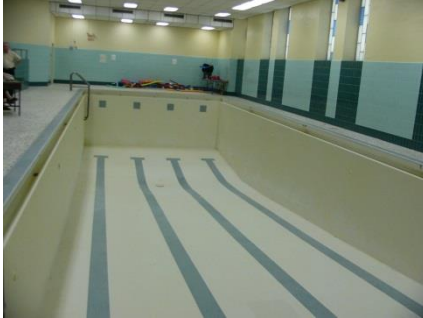
Location Surveyed: Westminster Historic Gym	Uniform Federal Accessibility Standards (UFAS) (unless noted otherwise)	Existing Measurements or Summary of Non-compliance	Photographs, if Available (enlarge electronically)	Remedial Action UFAS Standards (unless noted otherwise)
<p><b>Gym</b></p> <p><b>Lower Level</b></p> <p><b>Swimming pool</b></p> <p><b>Restrooms</b></p> <p><b>Locker rooms</b></p>	<p>Existing facility standards (34 C.F.R. §§ 104.21 and 104.22)</p> <p>Anti-discrimination standards (34 C.F.R. § 104.4)</p> <p>Guidance for pool: Section 1009 of the 2010 ADA Standards for Accessible Design (2010 Standards) at <a href="http://www.ada.gov/regs2010/2010ADASTandards/2010ADASTandards_pr_t.pdf">http://www.ada.gov/regs2010/2010ADASTandards/2010ADASTandards_pr_t.pdf</a>.</p> <p>Guidance for locker rooms: Sections 222 and 803.</p> <p>Guidance for Restrooms: Toilet Rooms: 4.1.2(10) and 4.22, including 4.16 (water closets or toilets), 4.17 (toilet stalls), 4.18 (urinals), 4.19 (lavatories or sinks and mirrors), 4.26 (grab bars), and 4.27 (controls and operating mechanisms).</p> <p>Guidance: 4.30: Signage: See 4.30.2-5 requirements pertaining to character proportion, color contrast, raised characters or symbols, and symbols of accessibility. See also 4.30.6: Interior signage shall be located alongside the door on the latch side and shall be mounted at a height of between 54" and 66" above the finished floor.</p>	<p>Access from the Gym's main level to the lower level (or basement) is via stairs only. The restrooms, locker rooms, swimming pool, and some classrooms are located in the lower level and are not accessible to individuals with mobility impairments. There are additional stairs to access the swimming pool from the locker rooms.</p> <p>The restrooms, locker rooms with restrooms, and swimming pool are not accessible for individuals with mobility impairments. The swimming is used for aquatics classes, recreational swimming, and occasional outside classes and programs, such as Red Cross classes.</p> <p>The swimming pool dimensions are: Length of pool: 60'8" Width of pool: 20'5" Raised lip around pool: 9" No sloped entry No pool lift</p> <p>Classes held in the lower level of the Gym could be relocated for an individual with a mobility impairment.</p> <p>OCR did not measure the locker rooms because those rooms, the restrooms and the swimming pool are inaccessible to individuals with mobility impairments. If the College chooses to make the pool accessible, there appear to be some compliance concerns (e.g. the raised walkway in the shower area).</p>

<p>Inaccessible swimming pool in lower level of the Gym.</p>

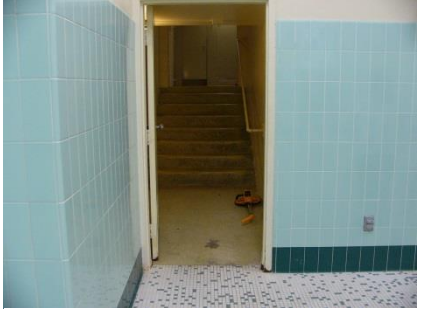
<p>Stairs from women's locker room to access the swimming pool.</p>

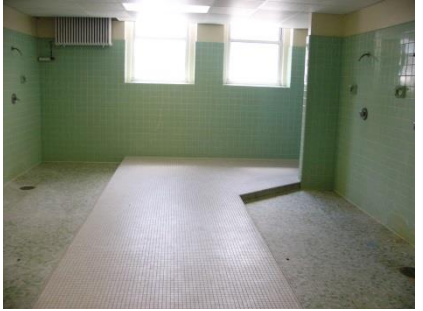
<p>Non-complying shower in the men's locker room.</p>	<p>Provide OCR with a plan to provide lower level access to individuals with mobility impairments, and alter the existing restrooms, locker rooms, and swimming pool so these areas are accessible, or provide a plan to offer these facilities at another location on campus that is accessible and connects to an accessible route. In addition, if the College continues to utilize the main level of the Gym, and the lower level is not accessible, provide a plan to offer accessible restrooms (or a unisex restroom) on the main level.</p>

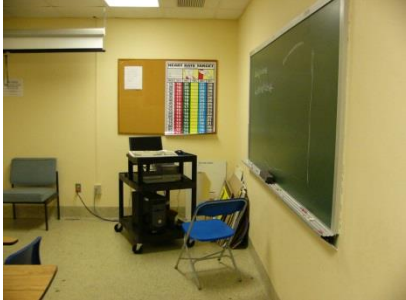
<p>Ceiling-mounted hanging screen in a classroom in the lower level of the Gym.</p>	<p>Provide a fixed barrier detectable by canes under any protruding objects or provide OCR with another plan to reconfigure or eliminate each protrusion. In addition, remove any objects that are less than 80” above the floor (such as the hanging screen in the classroom), unless there is a cane-detection area (where appropriate). See Fig. 8(a), below. 34 C.F.R. §§ 104.4 and 104.21.</p>

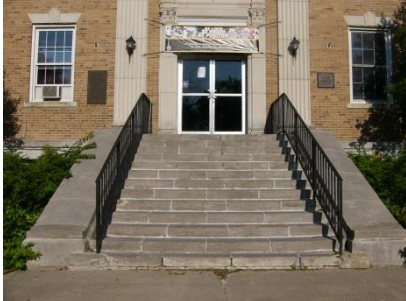
<p><b>Gym:</b></p> <p><b>Stairs connecting all levels</b></p>	<p>Existing building standards: 34 C.F.R. §§ 104.21 and 104.22</p> <p>Anti-discrimination standards: 34 C.F.R. § 104.4.</p> <p>Guidance: Stairs:</p> <p>4.1.2(4) and 4.9: Stairs connecting levels that are not connected by an elevator shall comply with 4.9.</p> <p>4.9.4. Handrails. Stairways shall have handrails at both sides of all stairs. Handrails shall comply with 4.26 and 4.9.4 (1) – (7).</p>	<p>Ensure any holes or breaks in stairs and any loose or unstable handrails are repaired to prevent safety hazards.</p> <p>See OCR’s Staff Memorandum dated 3/8/1991 pertaining to Section 504 program accessibility (17 IDELR 613, p. 6) (individuals with disabilities should be provided equal protection from risk while participating in the recipient’s programs).</p> <p>Bottom stair leading to main Gym entrance is crumbling and needs repaired. (See photo in next column)</p> <p>Stairs to staff offices should have</p>

<p>Ensure any holes or breaks in stairs and any loose or unstable handrails are promptly repaired and properly maintained to prevent safety hazards for individuals with visual or mobility impairments utilizing the stairs and handrails. 34 C.F.R. §§ 104.4 and 104.21.</p>

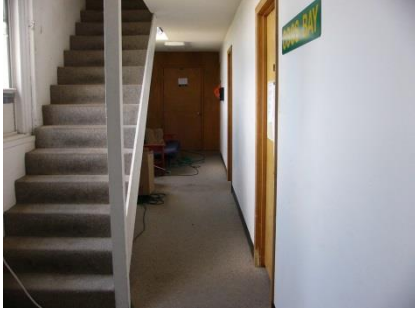
4.9.6: Outdoor stairs and their approaches shall be designed so that water will not accumulate on walking surfaces.	handrails. (see photo in next column)

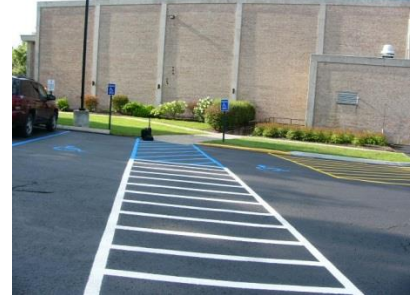
<p>Lot A, north side of Champ: Two designated accessible parking spaces: Both exceed 2% slope and both signs too low. Repair hole in access aisle.</p>

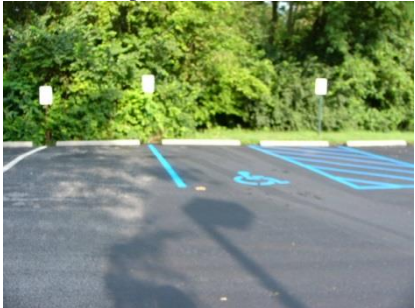
<p>Lot A, west of Champ: No accessible sign and the surface exceeds a 2% slope. Not located on an accessible route.</p>	<p>Ensure the accessible parking and access spaces in Lots A and B comply with 4.6, including slopes that do not exceed 2% in any direction, stable, firm, and slip-resistant surfaces, and signs indicating accessible parking that are not obscured by a vehicle parked in the space (see specific non-complying issues with photos in the columns to the left). See map and satellite view of College campus with designated parking lots near Champ Auditorium, below.</p>

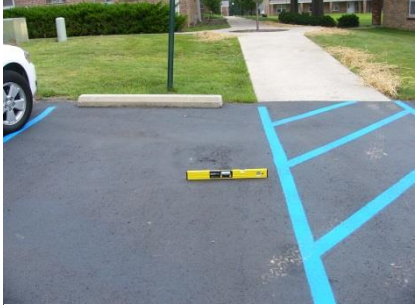
<p>Lot A, near front of Scott and Rice Halls: Two accessible parking spaces with shared access aisle: Both spaces and aisle exceed 2% slope [6.5% to 4.8%]. No connecting accessible route to north Champ entrance.</p>

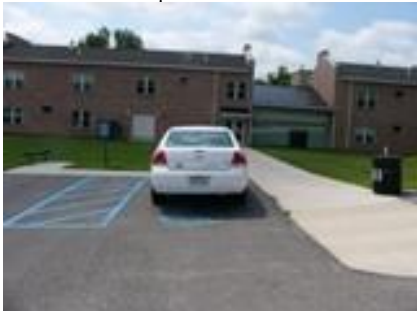
<p>Lot B, in front of North Hall: Two designated accessible parking spaces sharing an aisle. The signs for both spaces are too low (obscured by parked cars) and the slope exceeds 2%.</p>

<p>Partial view of Lot A north of Champ with green arrows identifying accessible parking areas closest to Champ.</p> <p>Add at least two more accessible parking spaces to Lot B in compliance with 4.6 (see Fig. 9, below). OCR recommends at least one van-accessible parking space in each parking lot with an aisle width of at least 96".</p>

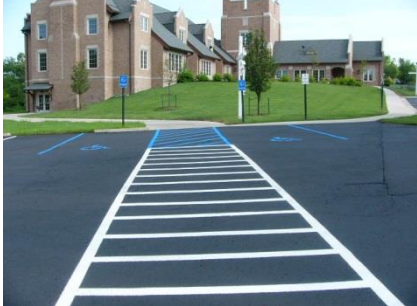
<p>Lot A, with view of Leadership Hall: Two designated accessible parking spaces that share access aisle exceed 2% slope.</p>

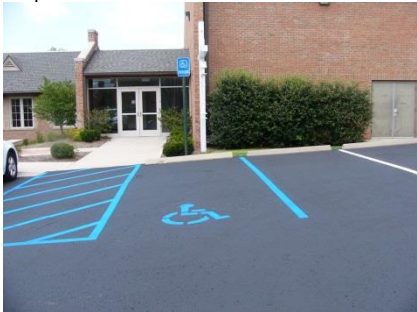
<p>Lot A, in front of Student Center: Accessible parking space and aisle exceed 2% slope.</p>

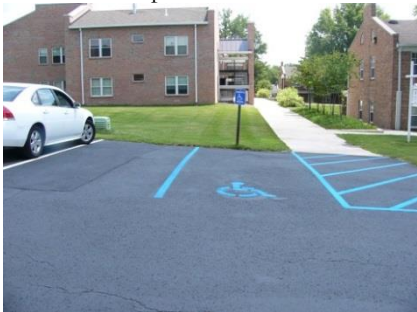
<p>Lot A, across from Student Center: Sign too low. Slope exceeds 2%. No connecting route to north entrance.</p>

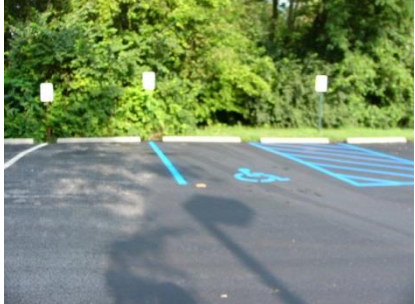
<p>Lot A: Designated accessible parking space on west side of Champ.</p>

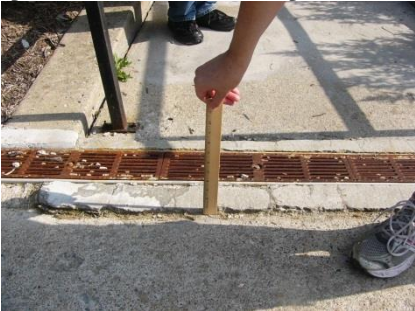
<p>Elevation change of more than 5" in front of the grate at the top of the ramp leading to the north Champ entrance.</p>	<p>Provide an accessible route that complies with 4.3, including width, slope, and changes in level requirements, that connects the accessible entrances of Champ Auditorium to accessible parking spaces. 4.3.</p> <p>The designated accessible parking space on the west side of Champ is not located close to the north or south designated accessible entrances of Champ and requires traveling on a route that is too steep. Consider relocating this designated accessible parking space near the south entrance and ensure the space complies with 4.6, and the route from the parking space to the south entrance complies with 4.3, including the slope requirement of 5% or less. The College may provide an alternative plan to OCR.</p> <p>Repair the beveled cement around the grate at the top of the north ramp.</p>

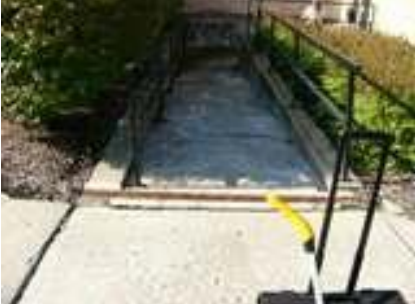
<p>Ramp to designated accessible north entrance of Champ Auditorium.</p>	<p>Lower the handrail and adjust slope of ramp to comply with 4.8.</p>

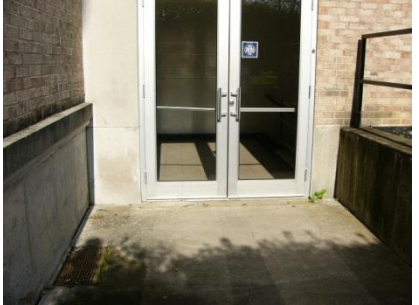
Location Surveyed: Champ Auditorium	Uniform Federal Accessibility Standards (UFAS) (unless noted otherwise)	Existing Measurements or Summary of Non-compliance	Photographs, if Available (enlarge electronically )	Remedial Action UFAS Standards (unless noted otherwise)
<p><b>Champ Auditorium</b></p> <p><b>North entrance doors (exterior and interior)</b></p>	<p>Existing facility standards (34 C.F.R. §§ 104.21 and 104.22)</p> <p>Anti-discrimination standards (34 C.F.R. § 104.4)</p> <p>Doors: 4.1.1(7) and 4.13:</p> <p>4.13.5: Doorways shall have a minimum clear opening of 32” with the door open 90 degrees, measured between the face of the door and the stop.</p> <p>4.13.11: The maximum force for pushing or pulling open an interior hinged door is 5 lbs. No opening force is specified for exterior doors.</p> <p>4.1.1(7)(c): All signs shall comply with 4.30. Accessible entrances shall be identified with the international symbol of accessibility.</p>	<p>Each independently operated exterior door’s opening was less than 32”.</p> <p>The opening force for both doors is 6-8 lbs. While there are no specific UFAS standards for maximum door opening force for exterior hinged doors, an opening force up to 8 lbs. for the exterior doors significantly exceeds the 5 lb. maximum force considered suitable for people with disabilities with respect to interior hinged doors. See 4.13.11.</p> <p>There is no sign with the international symbol of accessibility for the north entrance door.</p> <p>The opening force of the interior door leading to the auditorium was 11 lbs.</p>

<p>Designated accessible north entrance doors at the bottom of the ramp landing.</p>	<p>Ensure at least one of the exterior door leaves has a 32” clear opening width and appropriate maneuvering space.</p> <p>Install an automatic door opener for the exterior door at the bottom of the ramp in accordance with 4.13.12. While there is no specific opening force standard in UFAS for an exterior hinged door, the existing opening force could exclude individuals with disabilities from accessing the lower level of the building, contrary to 34 C.F.R. § 104.4 (Section 504 general anti-discrimination provisions) and 34 C.F.R. § 104.21 (Section 504 anti-discrimination provision regarding accessibility).</p> <p>Adjust interior door leading to auditorium so the maximum opening force is 5 lbs. Check all interior doors for complying opening force.</p> <p>Install a sign with the international symbol of accessibility for the north entrance door and provide directional signage to the accessible north entrance for auditorium access.</p>

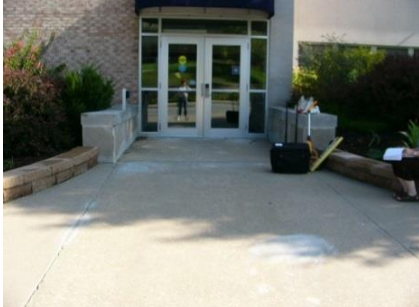
<p>Designated accessible south entrance of Champ Auditorium.</p>	<p>Install a sign with the international symbol of accessibility for the south entrance door.</p>

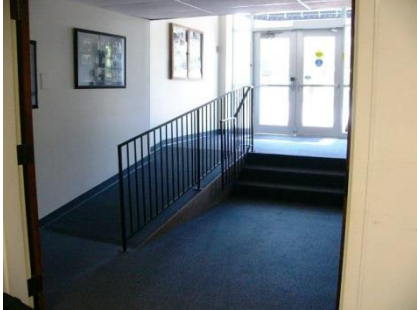
Location Surveyed: Champ Auditorium	Uniform Federal Accessibility Standards (UFAS) (unless noted otherwise)	Existing Measurements or Summary of Non-compliance	Photographs, if Available (enlarge electronically)	Remedial Action UFAS Standards (unless noted otherwise)
<p><b>Champ Auditorium</b></p> <p><b>Interior ramp inside the south entrance</b></p>	<p><u>Ramps: 4.8:</u></p> <p>4.8.2: Max. slope: 1:12 (or 8.33%). The max. rise for any run shall be 30". Ramps constructed on existing sites or in existing buildings or facilities may have slopes and rises as shown in Table 2 if space limitations prohibit the use of a 1:12 slope or less (see 4.1.6).</p> <p>4.8.3: Min. ramp width: 36"</p> <p>4.8.5: If a ramp run has a rise greater than 6" or a run greater than 72", then it shall have handrails on both sides.</p> <p>4.8.5(5): The top of handrail must be between 30" and 34" above ramp surface. At end of handrails, must be at least 12" of level handrail beyond the top &amp; bottom of the ramp segment.</p>	<p>The interior ramp inside the south entrance of Champ was constructed in 1996 and is subject to UFAS. The interior ramp dimensions are:</p> <p>Length of ramp: 10'2" Rise: 21" Width: 44 ¾" Slope using slope tool: 18.1% Handrail height: 38"</p> <p>The interior ramp exceeds the maximum slope of 1:12 or 8.33% pursuant to 4.8.2. In addition, the ramp exceeds the permissible slopes for ramps constructed in an existing building where space limitations prohibit the use of a 1:12 slope or less (see Table 2 slope standards in 4.1.6(4)(a)).</p> <p>The ramp requires handrails on both sides since the rise is greater than 6". The existing handrail is too high (38" but should be mounted between 30" and 34" above the ramp surface).</p>

<p>Interior ramp near south entrance of Champ.</p>	<p>Provide OCR with a plan to provide a complying ramp, lift or another method to provide access from the south entrance in compliance with UFAS standards.</p>

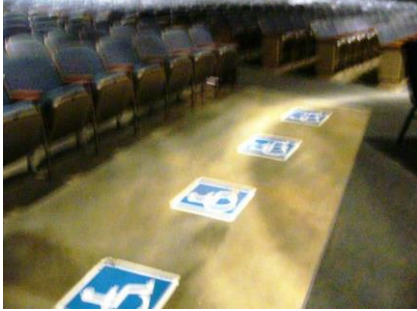
<p>Designated accessible seating in the auditorium.</p>	<p>Provide OCR with a plan to increase and disperse the number of accessible seats in the auditorium so that the accessible seats are an integral part of the seating plan and adjoin an accessible route that also serves as a means of egress in case of emergency. Ensure that the accessible seats are located to comply with Fig. 46, below, and provide lines of sight comparable to those for all viewing areas.</p> <p>In addition, ensure an accessible route connects wheelchair seating locations with performing areas, including stages, dressing rooms, restrooms, and other</p>

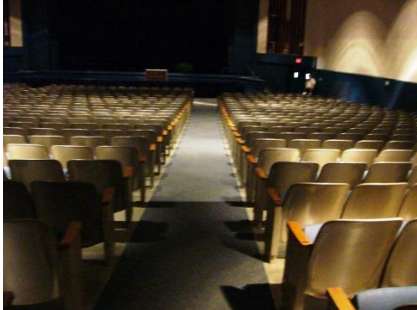
<p>View of auditorium from the back (looking at the stage).</p>

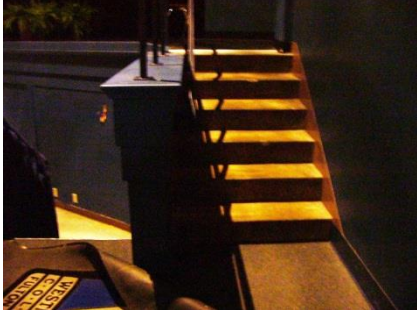
<p>Stairs leading to the stage and other performing areas, such as the dressing rooms and restrooms.</p>	<p>spaces used by performers, and ensure those performing areas are accessible.</p>

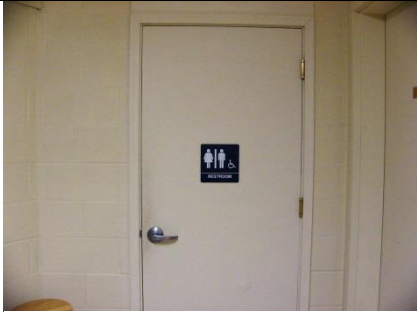
<p>Unisex restroom door with signage.</p>	<p>Alter the unisex restroom on the main level to comply with 4.2.2 and 4:30</p>

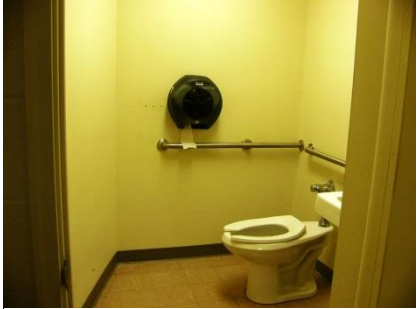
<p>Unisex restroom.</p>	(see above)
<p><b>Champ Auditorium:</b> <b>All levels</b></p> <p><b>Protrusions</b></p>	<p>Existing building standards: 34 C.F.R. §§ 104.21 and 104.22</p> <p>Anti-discrimination standards: 34 C.F.R. § 104.4.</p> <p>Guidance: Protruding objects:</p> <p>4.4.1: Wall-mounted objects with leading edges between 27" and 80" above the floor shall protrude no more than 4" into walks, halls, corridors, passageways, or aisles.</p> <p>4.4.2: Walks, halls, corridors, passageways, aisles, or other circulation spaces shall have 80" minimum clear head room (Fig. 8(a)).</p>	<p>The wall-mounted speakers in the music room and the paper towel dispenser in the unisex restroom are protruding objects that protrude more than 4" into the rooms.</p> <p>See OCR's Staff Memorandum dated 3/8/1991 pertaining to Section 504 program accessibility (17 IDELR 613, p. 6) (individuals with disabilities should be provided equal protection from risk while participating in the recipient's programs).</p>

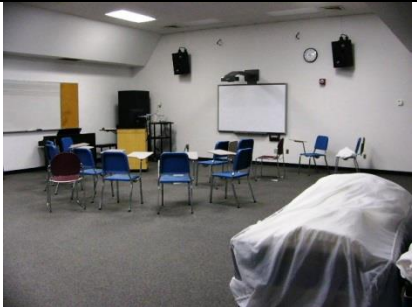
<p>Wall-mounted speakers in the music room.</p> <p>[Photograph redacted]</p> <p>Paper towel dispenser is a protrusion in the unisex restroom in Champ.</p>	<p>Provide a fixed barrier detectable by canes under any protruding objects or provide OCR with another plan to reconfigure or eliminate each protrusion. In addition, remove any objects that are less than 80" above the floor (such as the hanging screen in the classroom), unless there is a can-detection area (where appropriate). See Fig. 8(a), below. 34 C.F.R. §§ 104.4 and 104.21.</p>

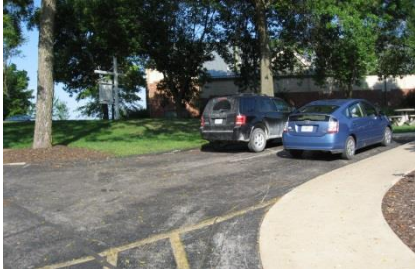
<p>Parking area with two parking spaces.</p>

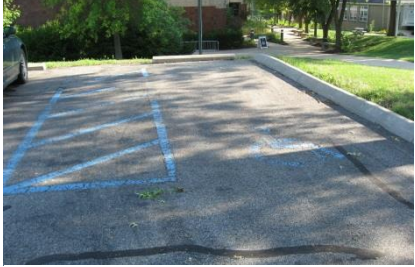
<p>Designated accessible parking space in Lot K.</p>

<p>Aerial view of Library and parking areas.</p>	<p>Lot K (also addressed in the table for the Gym, above): Increase the access aisle to 60” width for a car (see Fig. 9, below) or 96” width for a van for the accessible parking space (OCR recommends at least one van-accessible parking space), and include a sign designating the space as van-accessible if designated as van-accessible.</p> <p>Provide OCR with a plan to convert one of the parking spaces into an accessible parking space in the faculty parking area (with two parking spaces) near the southwest corner of the Library. Ensure the accessible parking space, aisle, and connecting route comply with 4.6 and 4.3.</p>

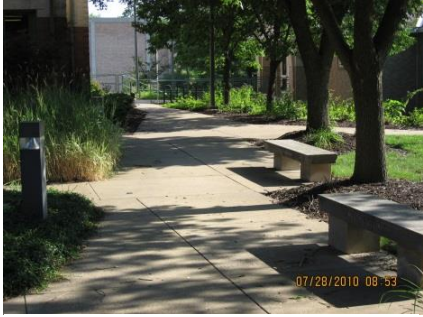
<p>07/28/2010 08:53</p> <p>Route from Lot K to west entrance of Library.</p>

<p>07/28/2010 08:54</p> <p>Crack in sidewalk near Library which results in a level change greater than .5".</p>	Provide an accessible route that complies with 4.3, including width, slope, and changes in level requirements, that connects the accessible entrances of the Library to accessible parking spaces. 4.3.  Any slope greater than 1:20 (5%) along an accessible route needs to have a ramp that complies with 4.8.

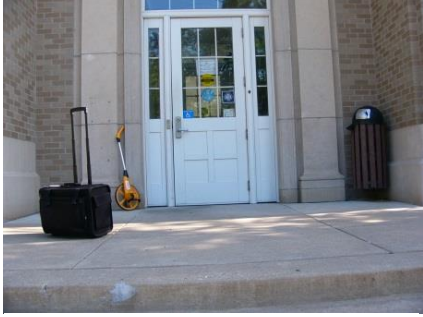
<p>South entrance to Library.</p>	Ensure the door width is at least 32" and ensure there is adequate space between the outside and inside doors based on Fig. 26, below.

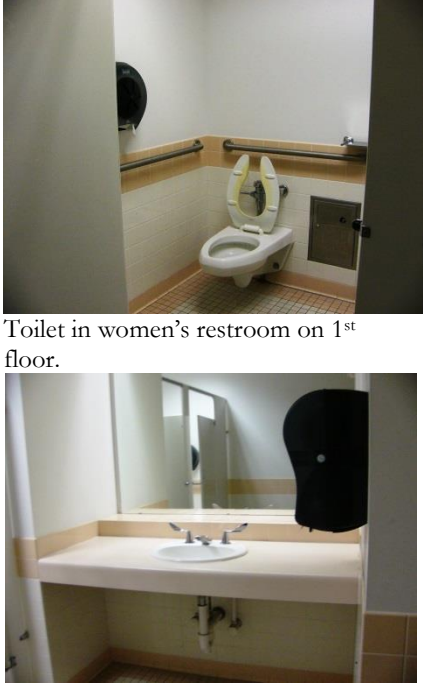
<p>Toilet in women's restroom on 1<sup>st</sup> floor.</p> <p>Sink in women's restroom on 1<sup>st</sup> floor.</p>	<p>Flush controls: The flush controls need to be installed on the wide side of the toilet area.</p> <p>Sink: Mount the sink rim or counter surface no higher than 34" above the floor.</p> <p>Paper Towel Dispenser: Provide a fixed barrier detectable by canes under any protruding objects or provide OCR with another plan to reconfigure or eliminate the protrusion.</p>

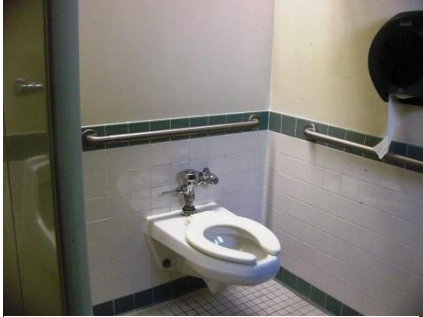
Location Surveyed: Reeves Library & Hazel Wing	Uniform Federal Accessibility Standards (UFAS) (unless noted otherwise)	Existing Measurements or Summary of Non-compliance	Photographs, if Available (enlarge electronically)	Remedial Action UFAS Standards (unless noted otherwise)
<p><b>Library</b></p> <p><b>Men's Restroom: 2<sup>nd</sup> Floor</b></p>	<p>4.16.3: Toilet height: The height of the toilet shall be 17" to 19" measured to the top of the toilet seat from the floor (see Fig. 29(b)). Seats shall not be sprung to return to a lifted position.</p> <p>Fig. 30(a): Centerline: The centerline of the toilet should be 18" from the side wall or partition.</p> <p>4.18.2: Urinal height: Urinals shall be stall-type or wall-hung with an elongated rim at a maximum of 17" above the floor.</p> <p>4.19.2: Lavatories: Height and clearance: Lavatories (or sinks within toilet rooms) shall be mounted with the rim or counter surface no higher than 34" above the finished floor. Provide a clearance of at least 29" from the floor to the bottom of the apron. Knee and toe clearance shall comply with Fig. 31.</p> <p>4.4.1: Protrusions: Wall-mounted objects with leading edges between 27" and 80" above the floor shall protrude no more than 4" into walks, halls, corridors, passageways, or aisles.</p>	<p>The top of the toilet seat is mounted 21" above the floor.</p> <p>The centerline of the toilet is 20.75" from the side wall.</p> <p>The urinal elongated rim is 24" above the floor.</p> <p>The lavatory (or sink) rim is 34.5" above the floor.</p> <p>The paper towel dispenser is a protrusion.</p>

<p>Toilet in men's restroom on the 2<sup>nd</sup> floor.</p>

<p>Toilet: Mount the top of the toilet seat 17" to 19" from the floor.</p> <p>Centerline: Install the toilet so that the centerline is 18" from the side wall.</p> <p>Urinal: Mount the urinal with the elongated rim at a maximum of 17" above the floor.</p> <p>Sink: Mount the sink rim or counter surface no higher than 34" above the floor. Ensure adequate knee and toe clearance under the sink.</p> <p>Protrusion: Provide a fixed barrier detectable by canes under any protruding objects or provide OCR with another plan to reconfigure or eliminate each protrusion.</p>

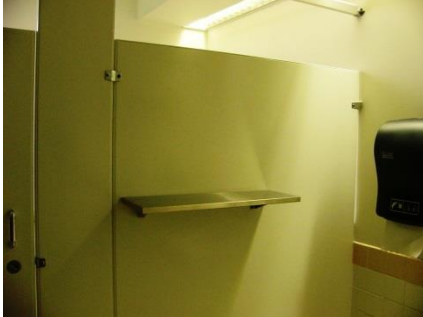
Location Surveyed: Reeves Library & Hazel Wing	Uniform Federal Accessibility Standards (UFAS) (unless noted otherwise)	Existing Measurements or Summary of Non-compliance	Photographs, if Available (enlarge electronically)	Remedial Action UFAS Standards (unless noted otherwise)
	<p>4.16.5: Flush controls: Flush Controls: The flush controls shall be hand-operated or automatic and shall comply with 4.27.4. Controls for flush valves shall be mounted on the wide side of the toilet areas no more than 44" above the floor. See also, 4.1.2(12) (Scope).</p> <p>4.4.1: Protrusions: Wall-mounted objects with leading edges between 27" and 80" above the floor shall protrude no more than 4" into walks, halls, corridors, passageways, or aisles.</p>	Shelf in women's restroom is a protrusion. (see photo in next column)

Protrusion: Provide a fixed barrier detectable by canes under any protruding objects or provide OCR with another plan to reconfigure or eliminate each protrusion.

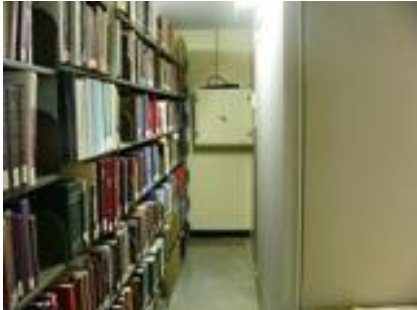
<p>Several stack aisles are less than 36" width on the left side of the west wing.</p>

<p>Several stack aisles are less than 36" width on the right side of the west wing.</p>	<p>Ensure that all areas of the Library comply with 8, including reading and study areas, stacks, reference rooms, reserve areas, and special facilities or collections.</p> <p>See Figures 55 and 56, below, for minimum clear aisle space and maximum reach heights.</p>

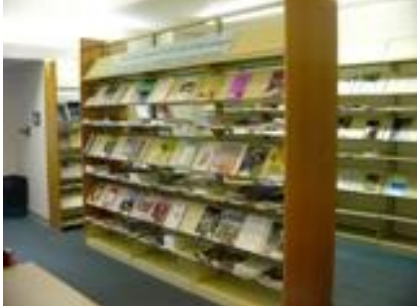
<p>The top shelf for magazines is too high (64") in magazine room for reach allowance (54" maximum reach height, 48" maximum preferred in UFAS).</p>

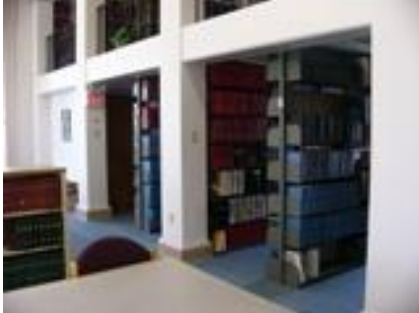
<p>Several stack aisles are less than 36" width on the 3<sup>rd</sup> floor.</p>

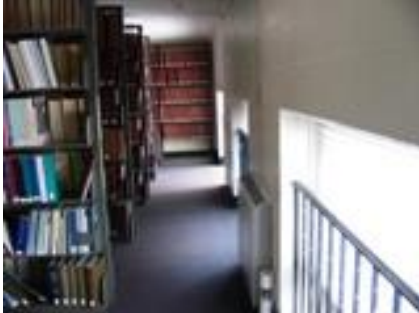
<p>Several stack aisles a 36" width on the 4<sup>th</sup> floor.</p>
