## **RESOLUTION AGREEMENT**

Westminster College  
OCR Docket Number 07102031

The Westminster College (College), Fulton, Missouri, submits this Resolution Agreement (Agreement) to the U.S. Department of Education, Office for Civil Rights (OCR), to resolve the allegations of discrimination based on disability against the College in the above-referenced complaint, and to ensure compliance with Section 504 of the Rehabilitation Act of 1973 (Section 504), 29 United States Code (U.S.C.) § 794, and its implementing regulations.

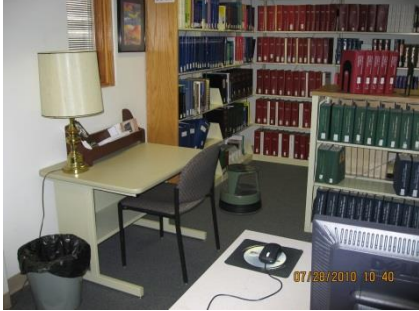
<p>Area in library near west entrance with book shelves and tables that encroach the minimum width of 36" of the accessible route.</p>

<p>Computers near circulation desk area.</p>	<p>Ensure a 36" accessible route to accessible elements, including tables, computer tables, bookcases, stacks, etc. is maintained in the library areas.</p> <p>While the computer tables do not appear to be fixed or built-in, an individual using a wheelchair should be able to independently access at least one computer table with adequate knee and toe clearances below the table, pursuant to 34 C.F.R. §§ 104.4 and 104.21 (Section 504 anti-discrimination provisions).</p>

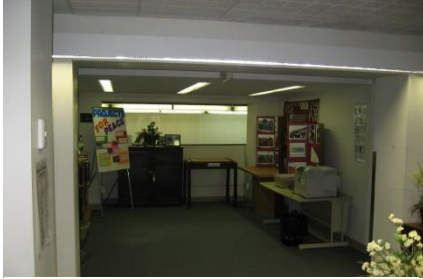
<p>The beam below the ceiling is less than 80" the floor.</p>	<p>Provide a fixed barrier detectable by canes under any protruding objects or provide OCR with another plan to reconfigure or eliminate each protrusion. In addition, remove any objects that are less than 80" above the floor (such as the hanging screen in the classroom), unless there is a can-detection area (where appropriate). See Fig. 8(a), below.</p>

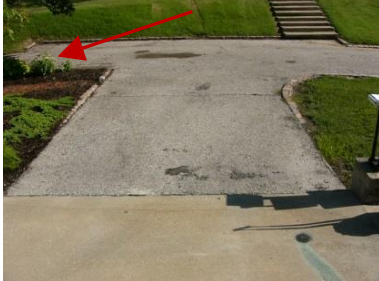
<p align="center">Church of St. Mary the Virgin</p>	
<p><b>Church:</b></p> <p><b>Parking space near ramp on the north side of the Church</b></p>	<p>Existing facility standards (34 C.F.R. §§ 104.21 and 104.22)</p> <p>Anti-discrimination standards (34 C.F.R. § 104.4)</p> <p>Guidance: Parking: 4.6</p> <p>4.1.1(5)(a): Scope: 1-25 total parking spaces require 1 accessible parking space (see table for additional spaces).</p> <p>4.6.2: Accessible parking spaces shall be located closest to the nearest accessible entrance on an accessible route.</p> <p>4.6.3: Accessible space: 96” min. width</p> <p>4.6.3: Accessible aisle: 60” min. width (96” min. width for van-accessible space)</p> <p>4.6.3: Accessible route: The access aisle shall be part of an accessible route to the facility entrance and shall comply with 4.3.</p> <p>4.6.3: Level Surface: The parking space and</p>	<p>The parking space at the top of the hill on the north side of the Church is not designated as an accessible parking space, yet this is the closest location to the designated accessible entrance of the Church (see photo in the next column). While there is a designated accessible parking space on the west side of Westminster Avenue near Seventh Street (see the second photo in the next column), that parking space does not comply with 4.6.</p>

<p align="center">North parking space.</p>

<p align="center">Designated accessible parking street on Westminster Avenue near Museum entrance with no access aisle.</p>	<p>Provide OCR with a plan to create at least one accessible parking space and aisle on the north side of the Church that complies with 4.6, including, but not limited to, proper signage, surface, the provision of an accessible route to the north accessible entrance of the Church, and directional signage indicating the location of the north designated accessible space.</p> <p>See UFAS Fig. 9, below, for required dimensions of accessible spaces and aisles.</p>

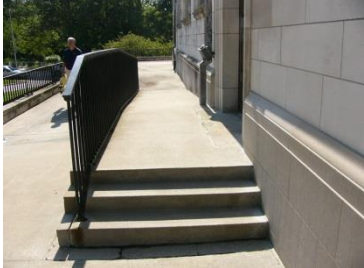
Location Surveyed: Church & Museum	Uniform Federal Accessibility Standards (UFAS) (unless noted otherwise)	Existing Measurements or Summary of Non-compliance	Photographs, if Available (enlarge electronically)	Remedial Action UFAS Standards (unless noted otherwise)
	<p>access aisles shall be level with surface slopes not exceeding 1:50 (2%) in all directions.</p> <p>4.6.4: Sign: Accessible spaces shall be reserved with a sign showing the symbol of accessibility (4.30.5) and signs shall not be obscured by a vehicle parked in the space.</p>			
<p><b>Church:</b></p> <p><b>Ramp on north side of Church</b></p>	<p><u>Ramps: 4.8</u></p> <p>4.8.2: Max. slope: 1:12</p> <p>4.8.2: Max. rise for any run: 30"</p> <p>4.8.3: Min. ramp width: 36"</p> <p>4.8.5: If a ramp run has a rise greater than 6" or a run greater than 72", then it shall have handrails on both sides.</p> <p>4.8.5(5): The top of handrail must be between 30" and 34" above ramp surface. At end of handrails, must be at least 12" of level handrail beyond the top &amp; bottom of the ramp segment.</p>	<p>Handrails are not provided on both sides of the ramp. See 4.8.5.</p> <p>The top of the ramp handrail is 40" above the ramp surface, instead of between 30" and 34" above the ramp surface. See 4.8.5(5).</p>

<p>Ramp on north side of Church.</p>	<p>Mount a handrail on the other side of the ramp in compliance with 4.8.5.</p> <p>Adjust or replace the existing ramp handrail so that the top of the handrail is between 30" and 34" above the ramp surface, in compliance with 4.8.5(5).</p>

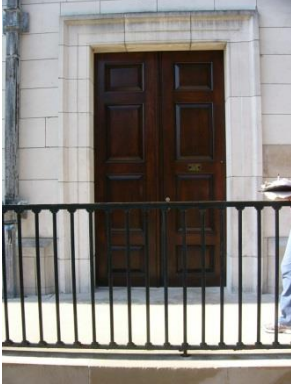
<p><b>Church:</b></p> <p><b>Designated Accessible entrance on the north side of the Church</b></p>	<p>Existing facility standards (34 C.F.R. §§ 104.21 and 104.22)</p> <p>Anti-discrimination standards (34 C.F.R. § 104.4)</p> <p>Guidance: Entrances (4.11) and Doors (4.13):</p> <p>4.14.1: Minimum Number: Entrances required to be accessible by 4.1 shall be part of an accessible route and shall comply with 4.3. Such entrances shall be connected by an accessible route to public transportation stops, to accessible parking and passenger loading zones, and to public streets or sidewalks if available (see 4.3.2(1)).</p>	<p>Door leaves: The outside door leaves are 27.5" wide each. However, at least one leaf should be 32" wide at a minimum. See 4.13.4. The inside door leaves are 24" wide each (one leaf should be 32" wide).</p> <p>Two Doors in Series: The two doors in series do not swing either in the same direction or away from the space between the doors.</p> <p>Threshold: The threshold for the outside door leaves is .75" in height, but should be no higher than .5". See 4.13.8.</p> <p>Door knob: The door knobs on the outside door leaves require tight grasping to open.</p>

<p>Designated accessible entrance on north side of Church.</p>	<p>Provide OCR with a plan to ensure the outside and inside doors at the north accessible entrance comply with 4.13, including minimum width, threshold, hardware, and space requirements. See UFAS Fig. 26, below.</p>

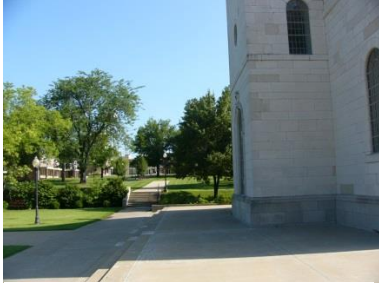
<p>Sidewalk near Church.</p>	<p>Ensure there is an accessible route that complies with 4.3, including width, slope, and changes in level requirements, that connects the accessible Church and Museum entrances to other other accessible buildings, facilities, elements, and spaces within the College site. 4.3.</p>

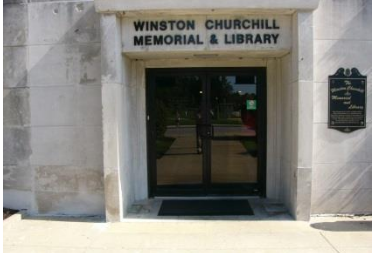
<p><b>Museum Entrance</b></p>	<p><u>Entrances (4.14) and Doors (4.13):</u></p> <p>4.14.1: Minimum Number: Entrances required to be accessible by 4.1 shall be part of an accessible route and shall comply with 4.3. Such entrances shall be connected by an accessible route to public transportation stops, to accessible parking and passenger loading zones, and to public streets or sidewalks if available (see 4.3.2(1)).</p> <p>4.13.7: Two Doors in Series: The minimum space between two hinged or pivoted doors in series shall be 48” plus the width of any door swinging into the space. Doors in series shall swing either in the same direction or away from the space between the doors (see Fig. 26).</p>	<p>The space between the Museum inside door (in the open position) and outside entrance door is less than 48”. See 4.13.7.</p>

<p>Outside entrance to Museum.</p>

<p>Space between the Museum outside and inside doors (2 doors in series).</p>	<p>Ensure the space between the Museum inside door and the outside entrance door is 48” plus the width of the inside door swinging into the space, in compliance with 4.13.7. See UFAS Fig. 26, below. The College should consider the option of a power or automatic door opener.</p>

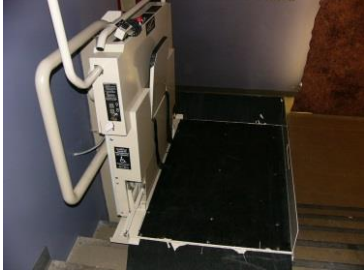
Location Surveyed: Church & Museum	Uniform Federal Accessibility Standards (UFAS) (unless noted otherwise)	Existing Measurements or Summary of Non-compliance	Photographs, if Available (enlarge electronically)	Remedial Action UFAS Standards (unless noted otherwise)
<b>Museum Lift</b>	<p><u>Platform Lifts: 4.11</u></p> <p>4.11.3: Unassisted entry/exit: If a platform lift is used, the lift should facilitate unassisted entry and exit from the lift.</p> <p>4.5.1: Floor Surfaces: Ground and floor surfaces along accessible routes and in accessible rooms and spaces, including floors, walks, ramps, stairs, and curb ramps, shall be stable, firm, slip-resistant, and shall comply with 4.5.</p> <p>4.27: Controls: Clear floor space complying with 4.2.4 that allows a forward or a parallel approach by a person using a wheelchair shall be provided at controls and other operable equipment. 4.27.2. See also, 4.27.3 (Height) and 4.27.4 (Operation) of controls.</p> <p>Section 504 regulation: 34 C.F.R. §§ 104.4(a) (Anti-discrimination provision).</p>	<p>The Museum lift cannot be operated independently; a Museum staff member must assist an individual with a disability to use the lift.</p> <p>The non-slip material is torn in places.</p>

<p>Museum lift near entrance.</p>	<p>Ensure the lift can be used and operated independently by an individual with a disability, including entering and exiting the lift without assistance, or provide OCR with a plan for providing a lift that can be operated independently.</p> <p>Ensure the lift complies with 4.11.2, including 4.2.4, 4.5, 4.27, and repair any torn non-slip material on the lift surface.</p>

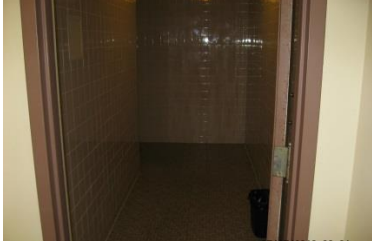
<p>Doorway leading to restroom area.</p>	<p>Move the large piece of furniture for an unobstructed passage through the doorway, in accordance with 4.13.5.</p>
<b>Museum: Men’s restroom door</b>	<p><u>Toilet Rooms (4.22): Doors (4.13)</u></p> <p>4.22.2: Doors: All doors to accessible toilet rooms shall comply with 4.13 and shall not swing into the clear floor space for fixtures.</p> <p>4.13.5: Clear Width: Doorways shall have a minimum clear opening of 32” with the door open 90 degrees, measured between the face of the door and the stop.</p>	<p>The door width is 29.5”.</p> <p>The threshold is 7/8” high.</p> <p>The door requires 9-10 lbs. of opening force.</p>

<p>Men’s restroom doorway.</p>	<p>Ensure door width has a minimum clear opening of 32” in accordance with 4.13.5.</p> <p>Adjust the threshold at the doorway so that it does not exceed .5” in height or provide a beveled threshold with a slope no greater than 1:2. 4.13.8.</p>

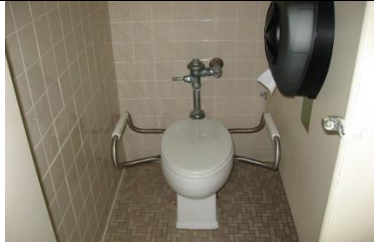
<p>(c) Rear Wall of Standard Stall</p> <p>Fig. 30(c): Grab bar height and width on rear wall of a standard stall.</p>
<p><b>Museum:</b></p> <p><b>Men's restroom:</b></p> <p><b>Toilet (Water Closet)</b></p>	<p><u>Toilet Rooms (4.22.4): Toilets (or Water Closets; 4.16):</u></p> <p>4.16.3: Height: The height of the toilet shall be 17" to 19" measured to the top of the toilet seat from the floor (see Fig. 29(b)). Seats shall not be sprung to return to a lifted position.</p> <p>Fig. 30(a): The centerline of the toilet should be 18" from the side wall or partition.</p> <p>4.16.5: Flush Controls: The flush controls shall be hand-operated or automatic and shall comply with 4.27.4. Controls for flush valves shall be mounted on the wide side of the toilet areas no more than 44" above the floor. See also, 4.1.2(12) (Scope).</p> <p>4.27.4. Operation: The flush controls must be operable without tight grasping, pinching or twisting.</p> <p>4.16.6: Dispensers: Toilet paper dispensers shall be installed within reach, as shown in Fig. 29(b). Dispensers that control delivery, or that do not permit continuous paper flow, shall not be used.</p>	<p>The height of the toilet from the floor to the top of the toilet seat is 16"</p> <p>The centerline of the toilet is less than 18" from a side wall.</p> <p>Toilet paper dispenser is installed 58" from the floor to the push lever, which exceeds the maximum control height of 44" above the floor.</p>

<p>Toilet in stall of men's restroom.</p>	<p>Provide a toilet that complies with the height range of 17" to 19" required by 4.16.3 (see Fig. 29(b), below), and a centerline of 18" from the side wall with a grab bar (Fig. 30(a)).</p> <p>Ensure that once grab bars are installed, the toilet paper dispenser is installed within the required reach, as shown in Fig. 29(b), below, and that large dispensers that do not fit below the grab bar are not used.</p>

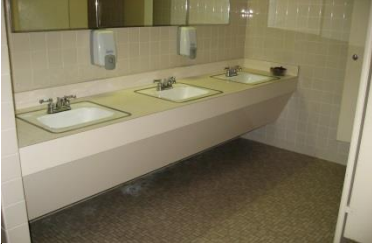
Location Surveyed: Church & Museum	Uniform Federal Accessibility Standards (UFAS) (unless noted otherwise)	Existing Measurements or Summary of Non-compliance	Photographs, if Available (enlarge electronically)	Remedial Action UFAS Standards (unless noted otherwise)
<p><b>Museum:</b></p> <p><b>Men's restroom:</b></p> <p><b>Lavatories &amp; mirrors</b></p>	<p><u>Toilet Rooms (4.22.6); Lavatories and Mirrors (4.19):</u></p> <p>4.19.2: Height and Clearances: Lavatories (or sinks within toilet rooms) shall be mounted with the rim or counter surface no higher than 34" above the finished floor. Provide a clearance of at least 29" from the floor to the bottom of the apron. Knee and toe clearance shall comply with Fig. 31.</p> <p>Fig. 31: Knee clearance height: At least 29" from the floor to the bottom of the apron, and at least 27" from the floor to the u of the lavatory. Knee clearance depth: 8" min. from front edge of lavatory counter to bottom of the lavatory, and 17" min. from front edge of lavatory to the back wall.</p> <p>Fig. 31: Toe clearance: 9" min. height from floor, and 6" max. toe depth of the 17" min. depth.</p> <p>4.19.3: Clear Floor Space: A clear floor space of 30" x 48" complying with 4.2.4 shall be provided in front of a lavatory to allow a forward approach. Such clear floor space shall adjoin or overlap an accessible route and shall extend a max. of 19" underneath the lavatory (see Fig. 32).</p> <p>4.22.6: If mirrors are provided, at least one shall comply with 4.19.6. Mirrors shall be mounted with the bottom edge of the reflecting surface no higher than 40" from the floor (see Fig. 31).</p>	<p>The knee clearance height from the floor to the bottom of the apron is 25".</p> <p>The maximum depth for knee clearance is 2.5" deep.</p> <p>The bottom edge of the mirror's reflecting surface is mounted 49" above the floor.</p>

<p>Provide one designated accessible lavatory that complies with the requirements of 4.19, including knee and toe clearances and clear floor space. See Figures 31 and 32, below.</p> <p>Provide a mirror for the designated accessible lavatory that is mounted no higher than 40" above the floor. 4.19.6.</p>

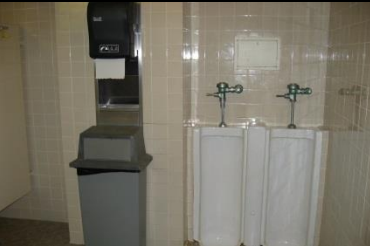
Location Surveyed: Church & Museum	Uniform Federal Accessibility Standards (UFAS) (unless noted otherwise)	Existing Measurements or Summary of Non-compliance	Photographs, if Available (enlarge electronically)	Remedial Action UFAS Standards (unless noted otherwise)
<p><b>Museum:</b></p> <p><b>Men's restroom:</b></p> <p><b>Urinals</b></p>	<p><u>Toilet Rooms (4.22.5): Urinals (4.18):</u></p> <p>4.22.5: If urinals are provided, then at least one shall comply with 4.18.</p> <p>4.18.2: Height: Urinals shall be stall-type or wall-hung with an elongated rim at a maximum of 17" above the floor.</p> <p>4.18.3: Clear Floor Space: 30" x 48" in front of urinals to allow a forward approach, which shall adjoin or overlap an accessible route and comply with 4.2.4.</p> <p>4.18.4: Flush Controls: Flush controls shall be hand-operated or automatic, and shall comply with 4.27.4, and shall be mounted no more than 44" above the floor.</p>	<p>The flush controls are mounted 47" above the floor.</p>

<p>Two urinals in the men's restroom.</p>	<p>Designate an accessible urinal and mount the flush controls no higher than 44" above the floor, in accordance with 4.18.4.</p> <p>Ensure the designated accessible urinal complies with the required clear floor space. 4.18.3.</p>

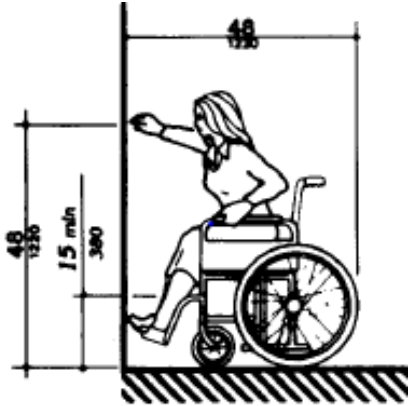
<p>Paper towel dispenser</p>	<p>Mount the paper towel dispenser to comply with 4.27, including front or side reaches. See Figure 5(a), in third column, and Figure 6(b), below.</p> <p>Provide a fixed barrier detectable by canes under the paper towel dispenser (such as a complying wall-mounted garbage receptacle or other barrier) or provide OCR with another plan to reconfigure or eliminate the protrusions in compliance with 4.4.1.</p>

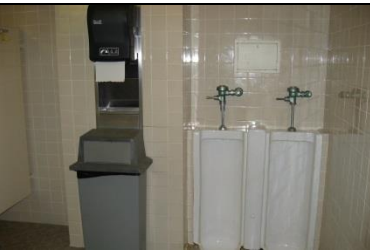
<p><b>Museum:</b></p> <p><b>Men's restroom:</b></p> <p><b>Controls and Dispensers</b></p> <p><b>Protrusions</b></p>	<p><u>Toilet Rooms (4.22.7): Controls and Operating Mechanisms (4.27):</u></p> <p>4.22.7: If controls, dispensers, receptacles, or other equipment are provided, at least one of each shall be on an accessible route and shall comply with 4.27.</p> <p>4.27.2: There must be at least 30 x 48" clear floor space which allows either a forward or parallel approach to the dispensers, receptacles etc.</p> <p>4.27.3: The highest operable part of all controls, dispenser, receptacles, and other operable equipment shall be placed within at least one of the reach ranges specified in 4.2.5 and 4.2.6. Except where the use of special equipment dictates otherwise, electrical and communications system receptacles on walls shall be mounted no less than 15" above the floor.</p>	<p>The paper towel dispenser is mounted 56.5" from the floor to the paper delivery area, which is too high for a forward reach or a side reach.</p> <p>The paper towel dispenser also is a protrusion unless a permanent garbage receptacle is mounted under the dispenser.</p>

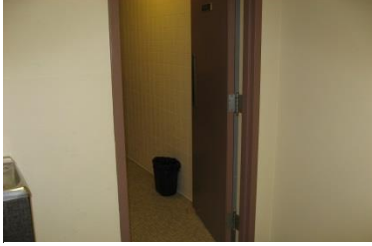
<p>High and Low (b) Side Reach Limits</p> <p>Fig. 6(b): High side reach.</p>
<b>Museum:</b>  <b>Women's restroom door</b>	<u>Toilet Rooms (4.22): Doors (4.13)</u>  4.22.2: Doors: All doors to accessible toilet rooms shall comply with 4.13 and shall not swing into the clear floor space for fixtures.  4.13.5: Clear Width: Doorways shall have a minimum clear opening of 32" with the door open 90 degrees, measured between the face of the door and the stop.  4.13.8: Threshold: Thresholds at doorways shall not exceed .75" in height for exterior sliding doors or .5" for other types of doors. Raised thresholds and floor level changes at accessible doorways shall be beveled with a slope no greater than 1:2.  4.13.9. Door Hardware: Handles, pulls, latches, locks, and other operating devices on accessible doors shall have a shape that is easy to grasp with one hand and does not require tight grasping, tight pinching, or twisting of the wrist to operate.  4.13.11: Opening Force: Interior doors must have an opening force of 5 lbs. or less.	The door width is 29.5".  The threshold is .75" high.  The door requires 10 lbs. of opening force.  The door handle requires grasping, which is not permitted.

<p>Women's restroom doorway.</p>

<p>Threshold at doorway to women's restroom.</p>	Ensure door width has a minimum clear opening of 32" in accordance with 4.13.5.  Adjust the threshold at the doorway so that it does not exceed .5" in height, or provide a beveled threshold with a slope no greater than 1:2. 4.13.8.  Adjust the opening force of the door to 5 lbs. or less. 4.13.11.  Replace the door handle with a shape that is easy to grasp with one hand and does not require tight grasping, tight pinching, or twisting of the wrist to operate. 4.13.9.

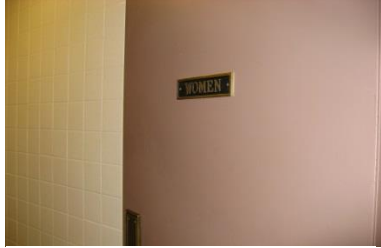
Location Surveyed: Church & Museum	Uniform Federal Accessibility Standards (UFAS) (unless noted otherwise)	Existing Measurements or Summary of Non-compliance	Photographs, if Available (enlarge electronically)	Remedial Action UFAS Standards (unless noted otherwise)
<b>Museum:</b>  <b>Signage for women's restroom door</b>	<p>4.1.1(7): All signs shall comply with 4.30 and accessible toilet facilities shall be identified with the international symbol of accessibility.</p> <p>4.30.2, 4.30.3, and 4.30.4: Signs shall comply with the character proportion, color contrast, and raised or indented characters or symbols.</p> <p>4.30.6: Interior signage shall be located on the latch side and shall be mounted at a height of between 54" and 66".</p>	<p>The sign is mounted on the door, instead of alongside the door on the latch side, and is not mounted between 54" and 66" above the floor.</p> <p>The sign does not include the international symbol of accessibility and does not comply with the required character proportion.</p>

<p>Sign on women's restroom.</p>	<p>Mount a sign with the international symbol of accessibility on the latch side of the door between 54" and 66" above the finished floor. 4.30.6</p> <p>Ensure the sign complies with 4.30.2, 4.30.3, and 4.30.4.</p>

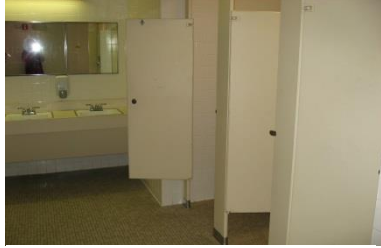
<b>Museum:</b>  <b>Women's restroom:</b>  <b>Toilet Stalls</b>	<p><u>Toilet Rooms (4.22.4): Toilet Stalls (4.17)</u></p> <p>4.17.3: Size and Arrangement: The arrangement of toilet stalls shall comply with Fig. 30(a). The stall must be at least 60" wide per Fig. 30(a). Toilet stalls with a min. depth of 56" shall have wall-mounted water closets (toilets). If the depth of toilet stalls is increased at least 3", then a floor-mounted water closet may be used. Arrangements shown for stalls may be reversed to allow either a left or right-handed approach. Stall door must be located at the open side of toilet per Fig. 30(a). See exception.</p> <p>4.17.4: Toe Clearances: In standard stalls, the front partition and at least 1 side partition shall provide a toe clearance of at least 9" above the floor. If the depth of the stall is greater than 60", then the toe clearance is not required.</p> <p>4.17.5: Doors: Toilet stall doors shall comply with 4.13. If toilet stall approach is from the latch side of the stall door, clearance between the door side of the stall and any obstruction may be reduced to a minimum of 42".</p>	<p>Stall doorway width: 22.5" (the stall opening should be a min. width of 32" per 4.17.5 and 4.13.5).</p> <p>Dimensions of stall: 56" deep x 33" wide (the stall width should be at least 60" wide).</p> <p>Toilet is floor-mounted, not wall-mounted. A wall-mounted toilet is required for a stall depth of 56" per 4.17.3.</p> <p>The stall does not have mounted or complying grab bars as required by 4.17.6.</p>

<p>Three toilet stalls in women's restroom.</p>

<p>Toilet in stall is floor-mounted.</p>	<p>Designate an accessible toilet stall and reconfigure that stall in the women's restroom to comply with each requirement of 4.17. See also, Figures 28-32.</p>

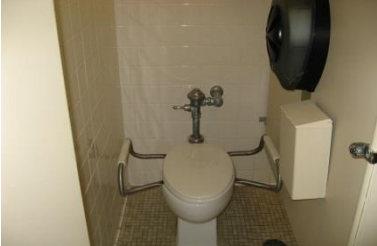
<p><b>Museum:</b></p> <p><b>Women's restroom:</b></p> <p><b>Toilet (Water Closet)</b></p>	<p><u>Toilet Rooms (4.22.4): Toilets (or Water Closets; 4.16):</u></p> <p>4.16.3: Height: The height of the toilet shall be 17" to 19" measured to the top of the toilet seat from the floor (see Fig. 29(b)). Seats shall not be sprung to return to a lifted position.</p> <p>Fig. 30(a): The centerline of the toilet should be 18" from the side wall or partition.</p>	<p>The height of the toilet from the floor to the top of the toilet seat is 16"</p> <p>The centerline of the toilet is 16.5" from either side wall.</p>

<p>Toilet in stall of women's restroom.</p>	<p>Provide a toilet that complies with the height range of 17" to 19" required by 4.16.3 (see Fig. 29(b), below), and a centerline of 18" from the side wall with a grab bar (Fig. 30(a)).</p> <p>Ensure that once grab bars are installed, the toilet paper dispenser is installed within the required reach, as shown in Fig. 29(b), below, and that large dispensers that do not fit below</p>

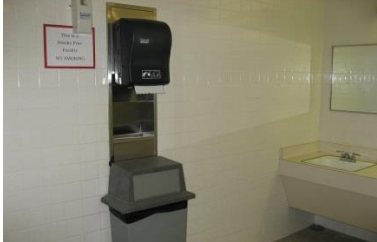
<p><b>Fig. 32</b> Clear Floor Space at Lavatories</p>
<p><b>Museum: Women's restroom: Controls and Dispensers</b></p>	<p><u>Toilet Rooms (4.22.7): Controls and Operating Mechanisms (4.27):</u></p> <p>4.22.7: If controls, dispensers, receptacles, or other equipment are provided, at least one of each shall be on an accessible route and shall comply with 4.27.</p> <p>4.27.2: There must be at least 30 x 48" clear floor space which allows either a forward or parallel approach to the dispensers, receptacles etc.</p> <p>4.27.3: The highest operable part of all controls, dispenser, receptacles, and other operable equipment shall be placed within at least one of the reach ranges specified in 4.2.5 and 4.2.6. Except where the use of special equipment dictates otherwise, electrical and communications system receptacles on walls shall be mounted no less than 15" above the floor.</p> <p>4.27.4: Controls and operating mechanisms shall be operable with one hand and shall not require tight grasping, pinching, or twisting of the wrist. The force required to activate controls shall be greater than 5 lbs.</p>	<p>The paper towel dispenser is mounted 56.5" from the floor to the paper delivery area, which is too high for a forward reach (maximum high forward reach is 48") or a side reach (maximum high side reach is 54").</p> <p>The paper towel dispenser also is a protrusion unless a permanent garbage receptacle is mounted under the dispenser.</p> <p>The sanitary napkin dispenser is mounted 51" from the floor to the coin drop, but too high to operate the levers. A side approach obstructs the toilet stall next to the dispenser.</p> <p>The sanitary napkin dispenser also is a protrusion, with a depth of 7" and mounted between 27" and 80" above the floor.</p>

<p>Paper towel dispenser in women's restroom.</p>

<p>Sanitary napkin dispenser.</p>	<p>Mount the paper towel and sanitary napkin dispensers to comply with 4.27, including front or side reaches. See Figures 5(a) and 6(b), below.</p> <p>Provide fixed barriers detectable by canes under the paper towel and sanitary napkin dispensers (such as a complying wall-mounted garbage receptacle or other barrier) or provide OCR with another plan to reconfigure or eliminate the protrusions in compliance with 4.4.1.</p>

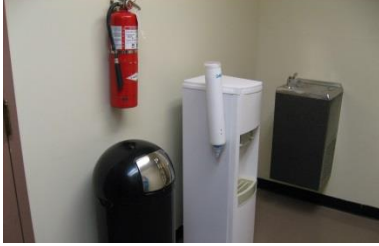
<p>High and Low Side Reach Limits Fig. 6(b): High side reach.</p>
<p><b>Museum:</b></p> <p><b>Corridor leading to restrooms:</b></p> <p><b>Drinking Fountain</b></p>	<p><u>Drinking Fountains/Water Coolers:</u> 4.15:</p> <p>4.1.2(9): Scope: If drinking fountains or water coolers are provided, approximately 50% of those provided on each floor shall comply with 4.15 and shall be on an accessible route. If only one drinking fountain or water cooler is provided on any floor, it shall comply with 4.15.</p> <p>4.15.2: Spout Height: The spout shall be no higher than 36", measured from the floor to the spout outlet.</p> <p>4.15.3: Spout Location: The spout shall be at the front of the unit and direct the water flow in a trajectory that is parallel to the front of the unit. The spout shall provide a flow of water at least 4" high.</p> <p>4.15.4: Controls: Controls and operating mechanisms shall be operable with one hand and shall not require tight grasping, pinching, or twisting of the wrist. The force required to activate controls shall be no greater than 5 lbs.</p>	<p>The free-standing water cooler allows a parallel approach (see Fig. 27(c), below) but is moveable and requires two hands, instead of one, to operate the controls and hold the water cup simultaneously. In addition, the removal of the paper cup requires grasping and pinching to pull it from the cup holder. Therefore, the wall-mounted drinking fountain will need to be altered or replaced to comply with 4.15.</p>

<p>Free-standing water cooler near wall-mounted drinking fountain.</p>	<p>Ensure the wall-mounted drinking fountain complies with the requirements of 4.15, including complying clearances. See Fig. 27(a) and (b), below, for a wall-mounted cantilevered unit:</p>

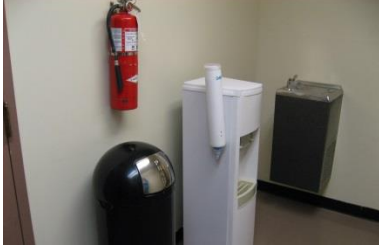
<p>(b) Clear Floor Space</p>
<p><b>Museum:</b></p> <p><b>Corridor leading to restrooms:</b></p> <p><b>Protrusions</b></p>	<p><u>Protrusions (4.1.1(3) and 4.4):</u></p> <p>4.1.1(3): Protrusions: All objects that protrude from surfaces or posts into circulation paths shall comply with 4.4.</p> <p>4.4.1: General: Wall-mounted objects with leading edges between 27" and 80" above the floor shall protrude no more than 4" into walks, halls, corridors, passageways, or aisles. Free-standing objects mounted on posts or pylons may overhand 12" max. from 27" to 80" above the floor or ground. Protruding objects shall not reduce the clear width of an accessible route or maneuvering space.</p>	<p>The fire extinguisher is a protrusion since it is mounted 40.5" above the floor with a depth of 5", and the garbage can below it is not fixed.</p>

<p>Fire extinguisher protrusion.</p>	<p>Provide a fixed barrier detectable by canes under the fire extinguisher (such as a complying wall-mounted garbage receptacle or other barrier) or provide OCR with another plan to reconfigure or eliminate the protrusion in compliance with 4.4.1. See Fig. 8(a), below.</p>

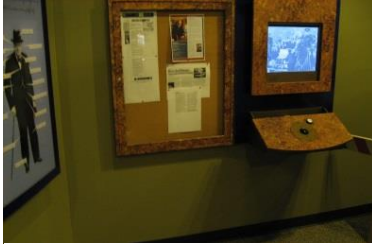
Location Surveyed: Church & Museum	Uniform Federal Accessibility Standards (UFAS) (unless noted otherwise)	Existing Measurements or Summary of Non-compliance	Photographs, if Available (enlarge electronically)	Remedial Action UFAS Standards (unless noted otherwise)
<b>Museum Exhibits:</b>	<p><u>Protrusions (4.1.1(3) and 4.4) (see text, above):</u></p> <p>4.1.1(3): Scope: Protruding objects            4.1.2(2): Scope: Overhanging objects            4.4.1: General            4.4.2/4.3.5: Head room</p>	<p>Wall-mounted protrusion: The dimensions for "The Latest Bulletin" exhibit in the Relevance Room: 29" H x 14" D.</p> <p>Post-mounted protrusion: The dimensions for the "Cold Warriors" exhibit in the Relevance Room: 29.5" H, 23.5" W x 13" D. Base of post: 1" H.</p> <p>Column-mounted protrusion: Dimensions for shelf with briefcase in the Cold War Room: 30" H x 11" D.</p> <p>Wall-mounted protrusion: Dimensions for 17<sup>th</sup> Century Bible display case in the Tradition Corridor: 36" H x 7" D.</p>

<p>The Latest Bulletin exhibit.</p>

<p>17<sup>th</sup> Century Bible display.</p>	<p>Provide a complying fixed barrier detectable by canes under the protruding object or provide OCR with another plan to reconfigure or eliminate each protrusion in compliance with 4.4. See Fig. 8(a) (wall-mounted objects), above, and Fig. 8(d) (post-mounted objects), below.</p> <p>In addition, ensure compliance with Fig. 7 (width of accessible route), when applicable.</p>

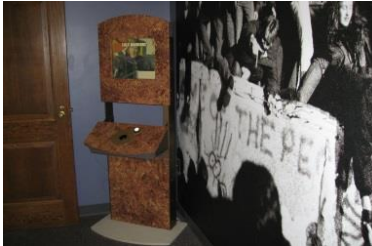
<p>Cold Warriors exhibit.</p>

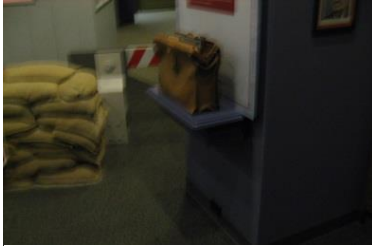
<p>Shelf with briefcase.</p>

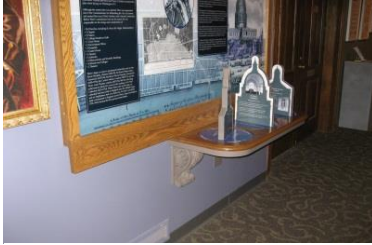
Location Surveyed: Church & Museum	Uniform Federal Accessibility Standards (UFAS) (unless noted otherwise)	Existing Measurements or Summary of Non-compliance	Photographs, if Available (enlarge electronically)	Remedial Action UFAS Standards (unless noted otherwise)
		<p>Wall-mounted protrusion: Dimensions for shelf with 3 churches display in the Chris Wren Hallway: 27.5" H x 19.5" D.</p> <p>Wall-mounted protrusion: Dimensions for the "Putting It All Together" display in the Chris Wren Hallway: 28.75" H x &gt;4" D.</p> <p>Wall-mounted protrusion: Dimensions for "The Church Today" display in the Chris Wren Hallway (to the right of the "Putting It All Together" display): 30" H x 4.75" D.</p> <p>Wall-mounted protrusion: Dimensions for the shelf with books for the "Reading and Riding" exhibit in the Churchill Formative Years area: 28.5" H x 12" D.</p> <p>Wall-mounted protrusion: Dimensions for the periscope exhibit in the Trenches Room: 48" H x 14.5" D. The step stool below is not fixed and it obstructs the min. clear width of the accessible route (31.5" width with step stool).</p>

<p>Shelf with 3 churches.</p>

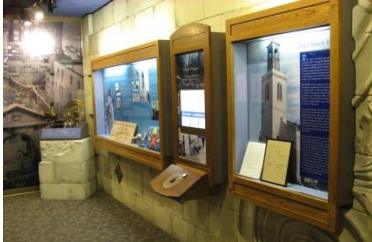
<p>"Putting It All Together" and "The Church Today" exhibits.</p>

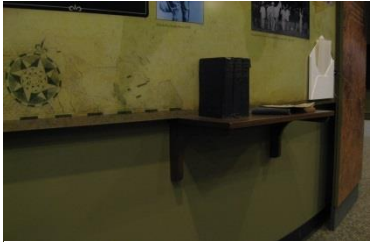
<p>Shelf with books.</p>

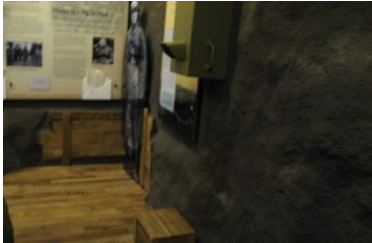
<p>Periscope exhibit.</p>

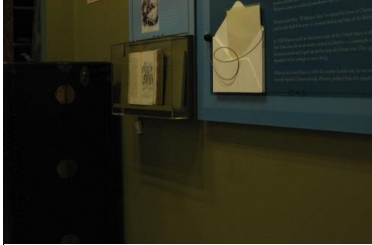
Location Surveyed: Church & Museum	Uniform Federal Accessibility Standards (UFAS) (unless noted otherwise)	Existing Measurements or Summary of Non-compliance	Photographs, if Available (enlarge electronically)	Remedial Action UFAS Standards (unless noted otherwise)
		<p>Wall-mounted protrusion: Dimensions for the “A Thousand Words a Day” book display case in the Wilderness Room: 30.5” H x 5.5” D.</p> <p>Wall-mounted protrusion: Dimensions for the “Fearful Convulsions” book display case in the Gathering Storm Room: 32” H x 7.5” D.</p>

<p>“A Thousand Words a Day” book.</p>

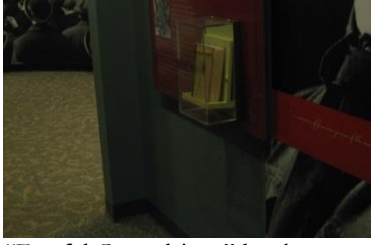
<p>“Fearful Convulsions” book display.</p>	
<b>Museum Theatre</b>	<p><u>Seating, Tables, &amp; Work Surfaces: 4.1.2(17) &amp; 4.32:</u></p> <p>4.1.2(17): If fixed or built-in seating, tables, or work surfaces are provided in accessible spaces, at least 5%, but always at least one, of seating spaces, tables, or work surfaces shall comply with 4.32.</p> <p>34 C.F.R. § 104.4 (Section 504 general anti-discrimination provisions)</p>	<p>The theater in the Sinews of Peace Room does not have a designated accessible wheelchair space. It appears the theater has fixed seating for at least 16 individuals.</p>

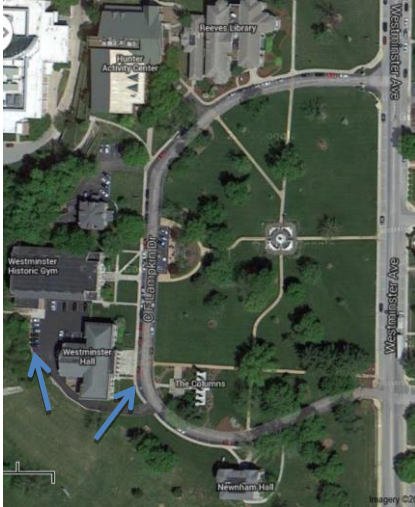
<p style="text-align: center;">Front view of Newnham Hall</p>	
<p><b>Newnham Hall:</b></p> <p><b>Parking and Accessible Route</b></p>	<p>Existing building standards: 34 C.F.R. §§ 104.21 and 104.22</p> <p>Anti-discrimination standards: 34 C.F.R. § 104.4.</p> <p>Guidance: Parking 4.6 and Accessible Route: 4.3</p> <p>4.3.2(1): At least one accessible route within the boundary of the site shall be provided from public transportation stops, accessible parking, and accessible passenger zones, and public streets or sidewalks to the accessible building entrance they serve.</p> <p>4.3.2(2): At least one accessible route shall connect accessible buildings, facilities, elements, and spaces that are on the same site.</p> <p>See 4.3.3 (Width), 4.3.4 (Passing Space), 4.3.5 (Head Room), 4.3.6 (Surface Textures), 4.3.7 (Slope), 4.3.8 (Changes in Levels), 4.3.9 (Doors), and 4.3.10 (Egress) requirements.</p>	<p>There are no accessible parking spaces for Newnham Hall. The closest accessible parking space is up the hill outside of Westminster Hall. The distance from that accessible space to the Newnham Hall designated accessible entrance in the back of the building is at least 450'4" (see satellite view in next column).</p> <p>However, the UFAS appendix section for accessible routes states that many individuals with disabilities can move at only very slow speeds; for many, traveling 200 ft. could take about 2 minutes, assuming the ground is level. On trips over 100 ft., individuals with disabilities are apt to rest frequently, which substantially increases their trip times, and in inclement weather, slow progress and resting can greatly increase the individual's exposure to the elements.</p> <p>In addition to the long distance, the accessible route from the parking areas near Westminster Hall to the Newnham Hall designated accessible entrance has several sections that significantly exceed a 5% slope (exceeding 10%).</p>

<p>The blue arrows point to existing designated accessible parking spaces for Westminster Hall in the satellite photo. The red arrow points to the designated accessible entrance in the back of Newnham Hall (on the south side). A long sidewalk that is too steep in several sections wraps around Newnham Hall on the east side for the accessible route to the south entrance. Only the lower level is accessible.</p>	<p>The College provided OCR information indicating that when students with mobility impairments are scheduled for classes, events, or to meet with faculty members housed in the first or second floors of Newnham Hall, the College classes or events are moved to an accessible classroom.</p> <p>The Career Services Office is located in the lower level of Newnham Hall. However, the existing route from parking spaces near Westminster Hall to Newnham Hall is too steep and the distance is too long for an individual in a wheelchair. The entrance door and restrooms do not fully comply with the requirements of UFAS.</p> <p>Therefore, please provide OCR with a plan to 1) create a complying route and accessible parking closer to Newnham Hall, 2) relocate the Career Services Office to an accessible building on campus, or 3) propose an alternative plan.</p>
